**OBSERVATIONS OF POST TSUNAMI
RECONNAISSANCE INVESTIGATIONS ALONG
EASTERN COASTAL TRACT OF INDIA
FOLLOWING THE DEVASTATING TSUNAMI OF
26TH DECEMBER 2004**

NIO/TR-08/2005

NATIONAL INSTITUTE OF OCEANOGRAPHY
DONA PAULA, GOA – 403004, INDIA

JULY 2005

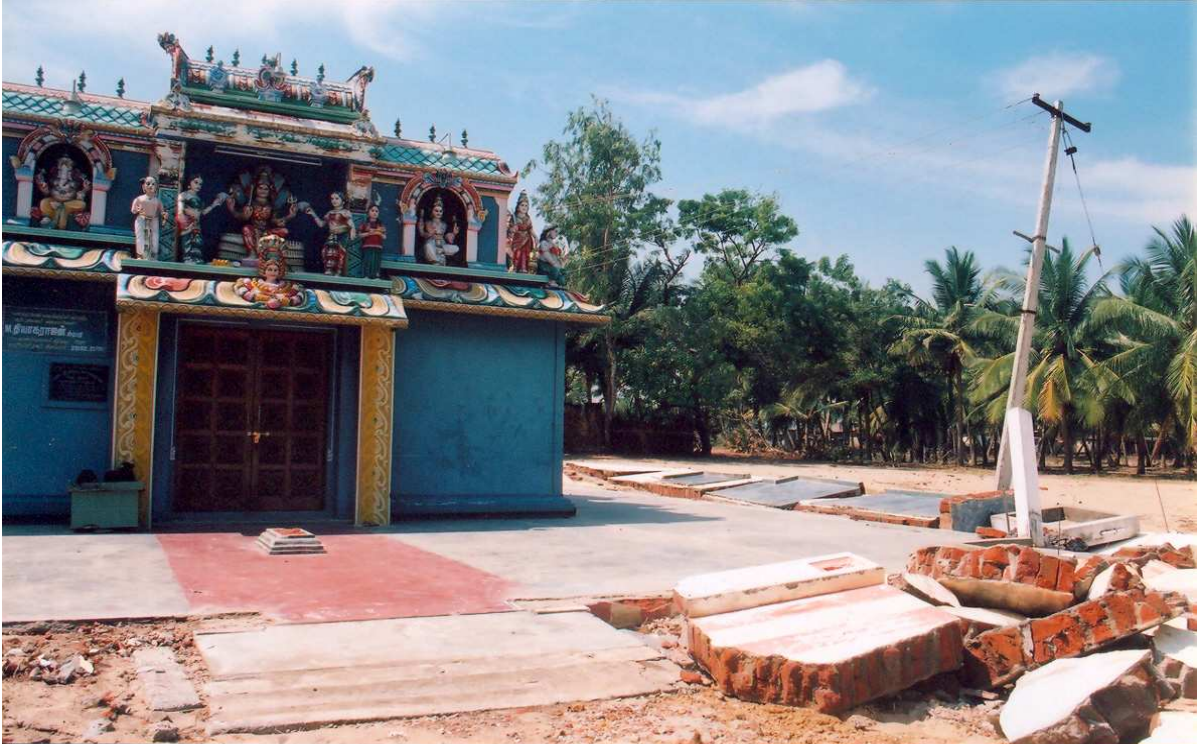
Plate 5. Failure of compound walls. Failures of such non-load bearing short walls are inevitable as they are not designed for lateral impact loads such as tsunami. (Reddiyarpettai)

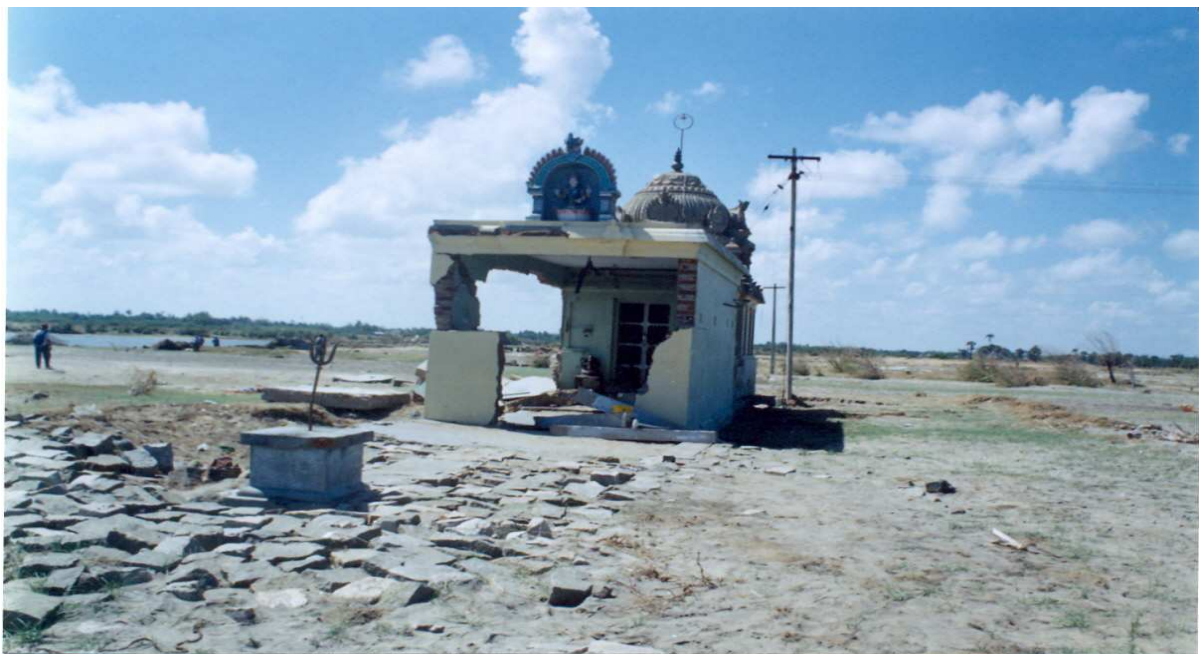
Houses/structures in the first row facing the sea seem to have failed primarily by the impact force of the tsunami waves and secondarily by scour due to rapidly moving tsunami waters (Plates 6 - 9). In some places the front row of houses were built over elevated ground consisting of silty sands (Plates 10 & 11). The tsunami waves caused heavy erosion of those ground and washed away the structures built over it. In some locations, the impact forces are believed to have been so powerful that even concrete pillars and steel structures could not withstand (Plates 12 & 13).

Plate 6. Damaged Cauery temple (Poompuhar) few tens of meters from sea. Isolated and smaller dimensional structures like this are less stable under undiffused tsunami flow due to lesser number of structural members in the lateral dimension.

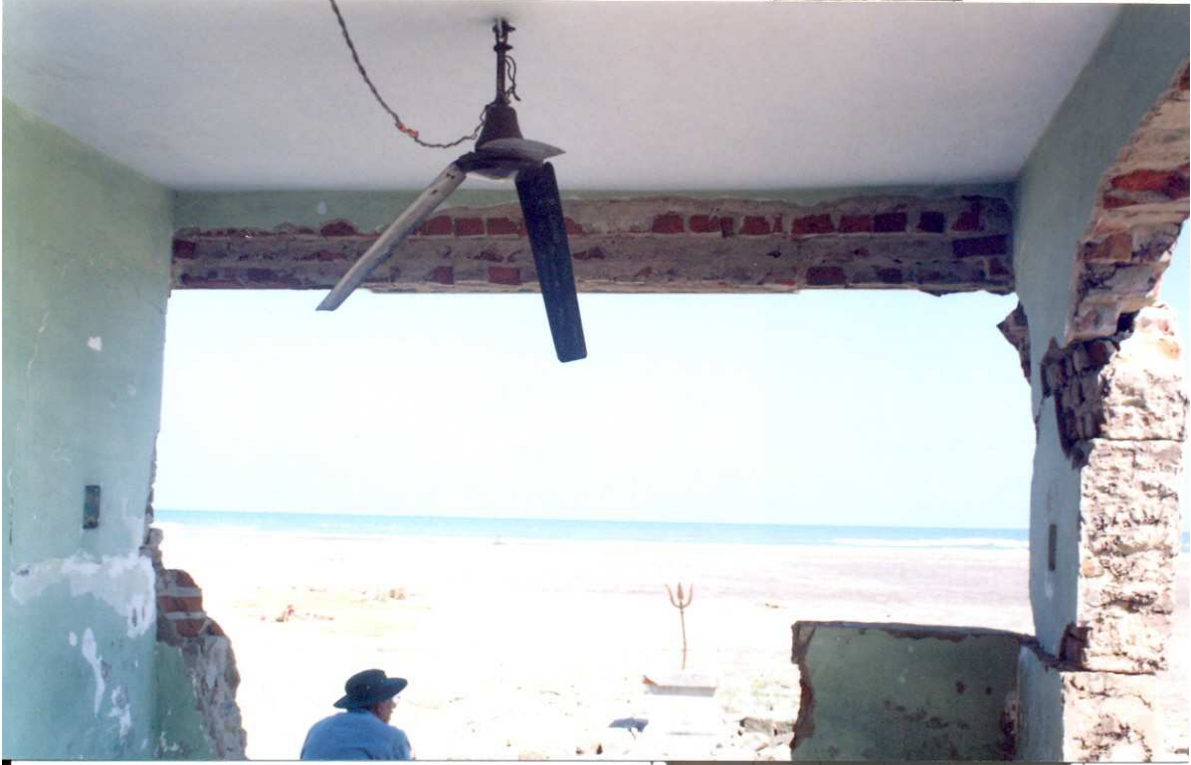
Plate 7. Proximity of this damaged Cauery temple (Poompuhar) to the sea can be perceived through this unobstructed view of sea in front.

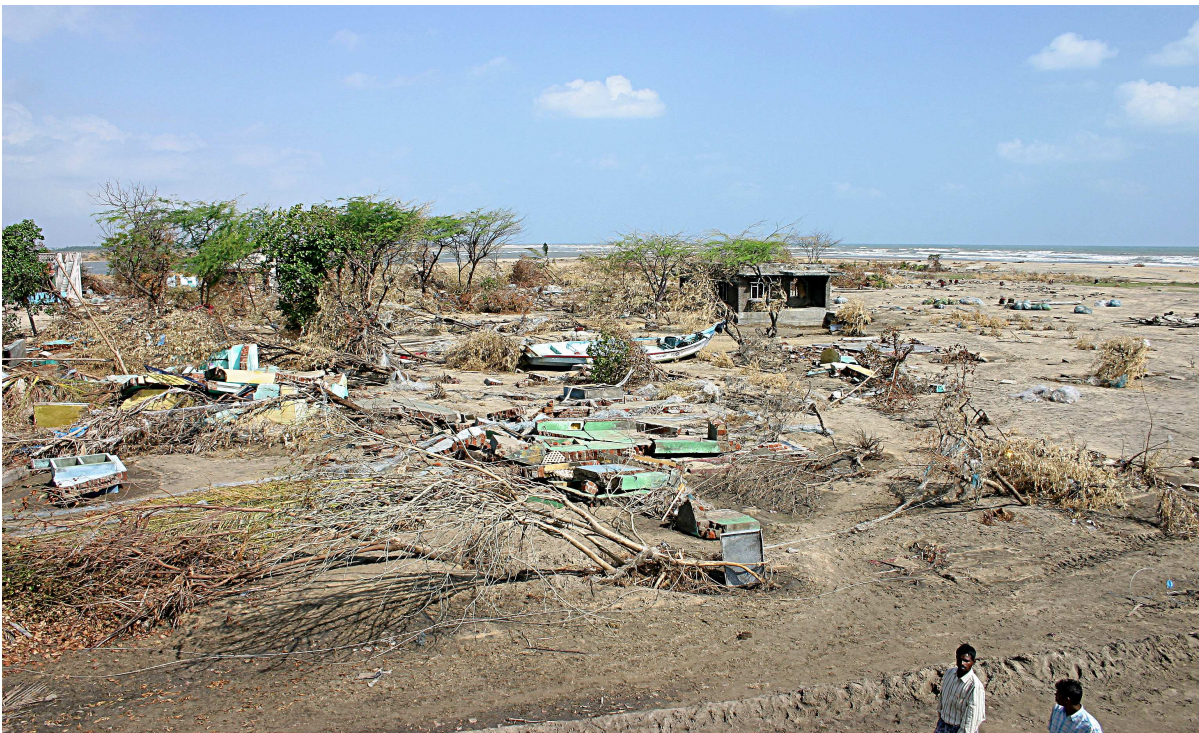
Plate 8. Structures with load bearing walls in close proximity to the sea which failed by the tsunami.

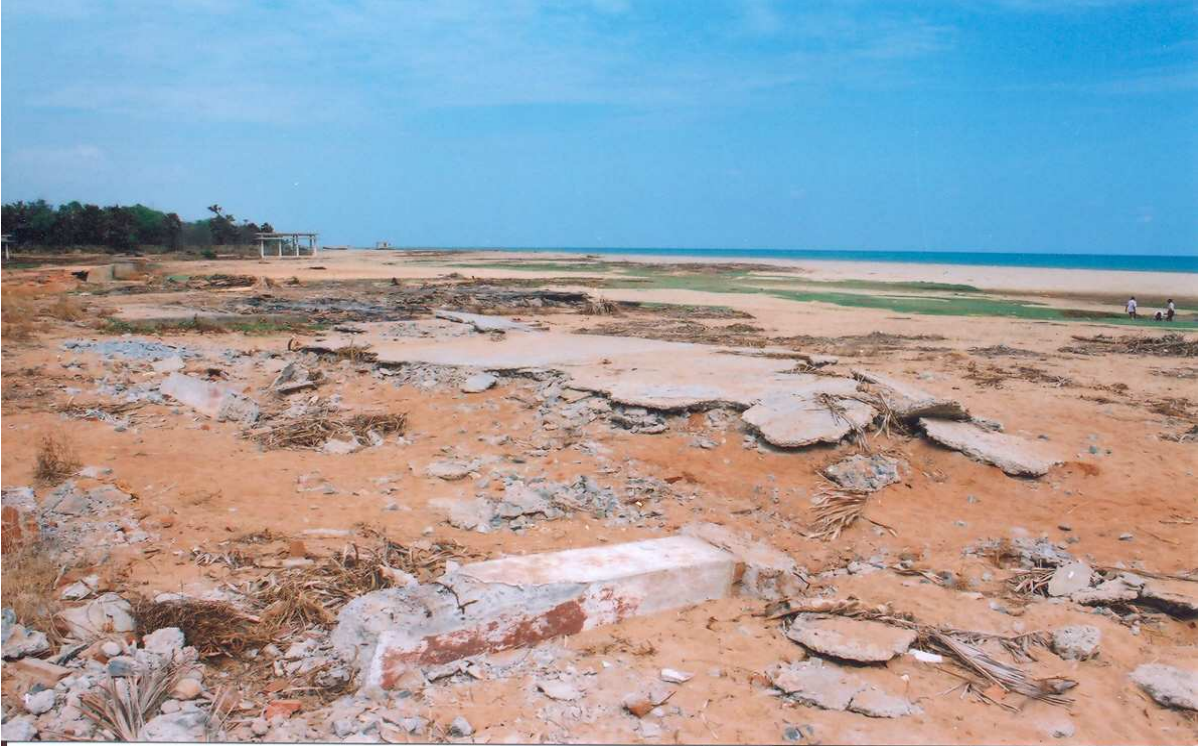
Plate 9. Tsunami damaged inappropriately designed structure built very close to the sea (Periyakalpet).

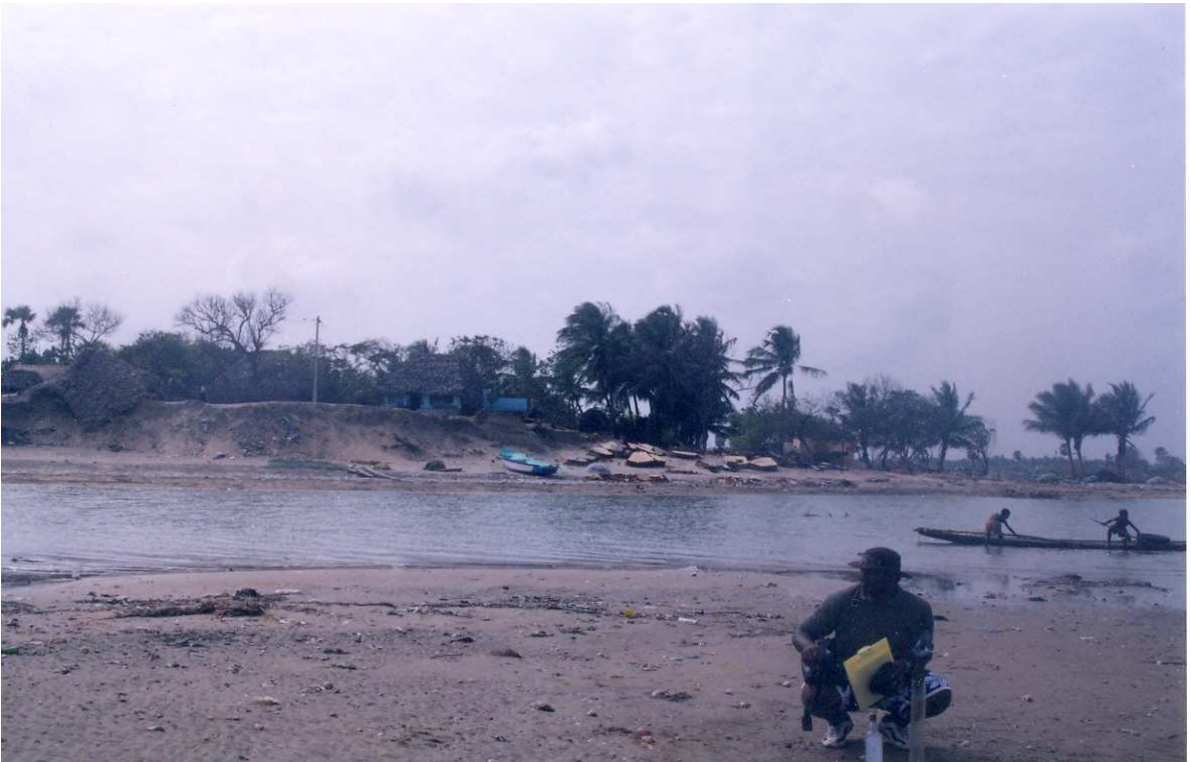
Plate 10. Front row houses built over elevated ground damaged due to tsunamigenic collapse of ground (Serudhur).

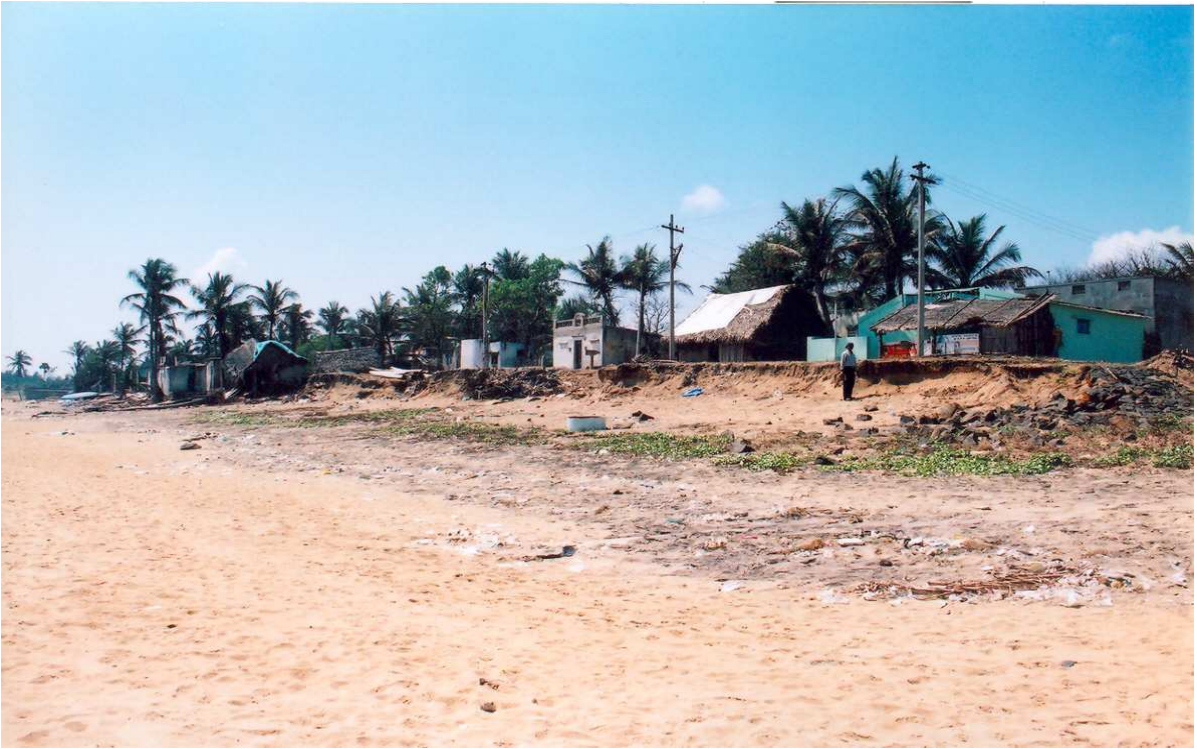
Plate 11. Failure of front row structures built right on the beach few tens of meters away from the sea (Karikattukuppam).

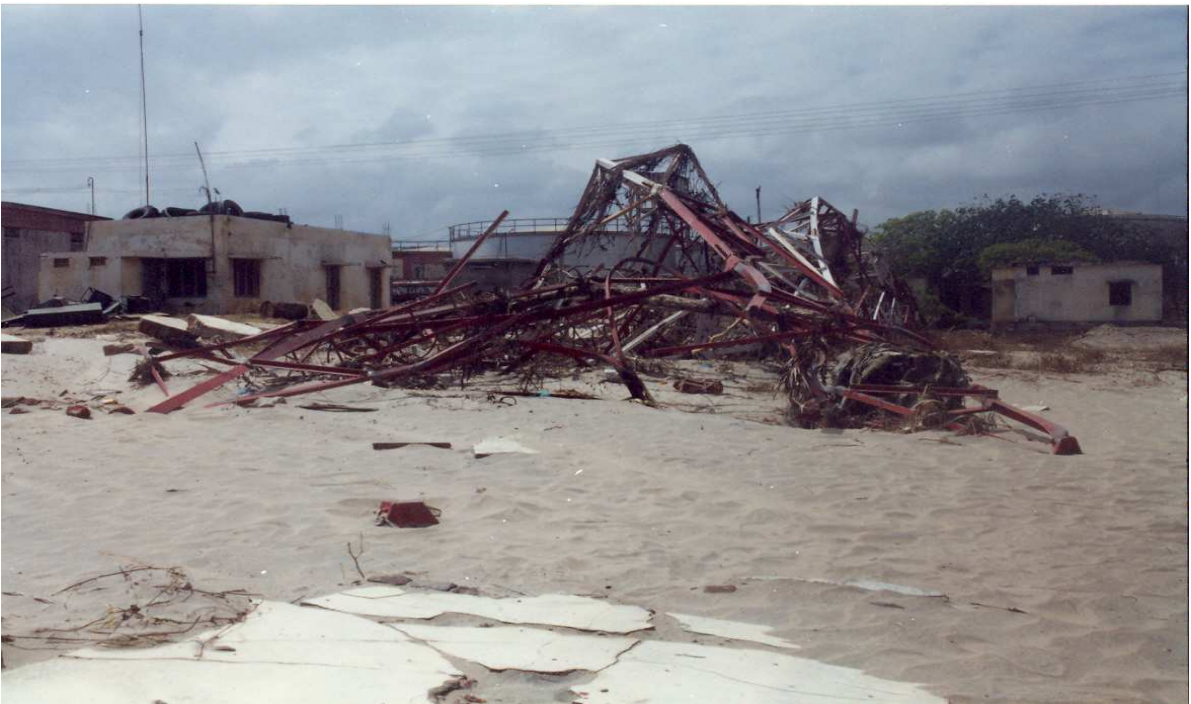
Plate 12. Power transmission tower at Nagapattinam failed by tsunami. The structure is of space-frame type with steel flats and angles

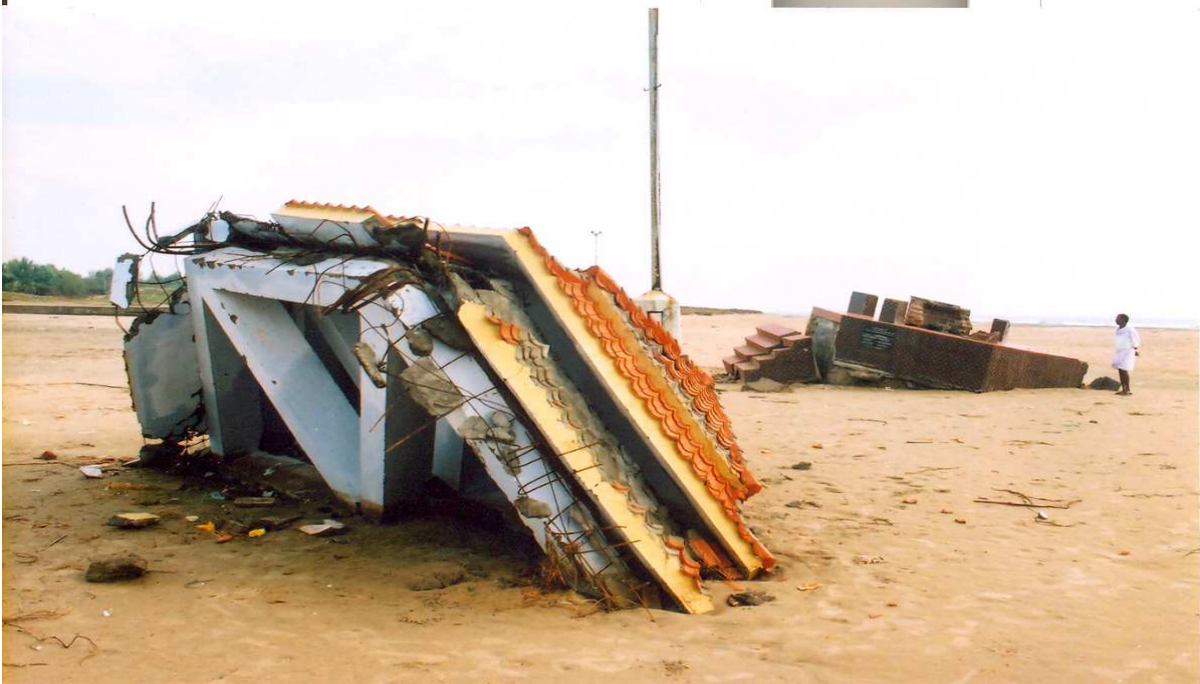
Plate 13. Tsunami damaged reinforced concrete structure on the beach (Cuddalore)

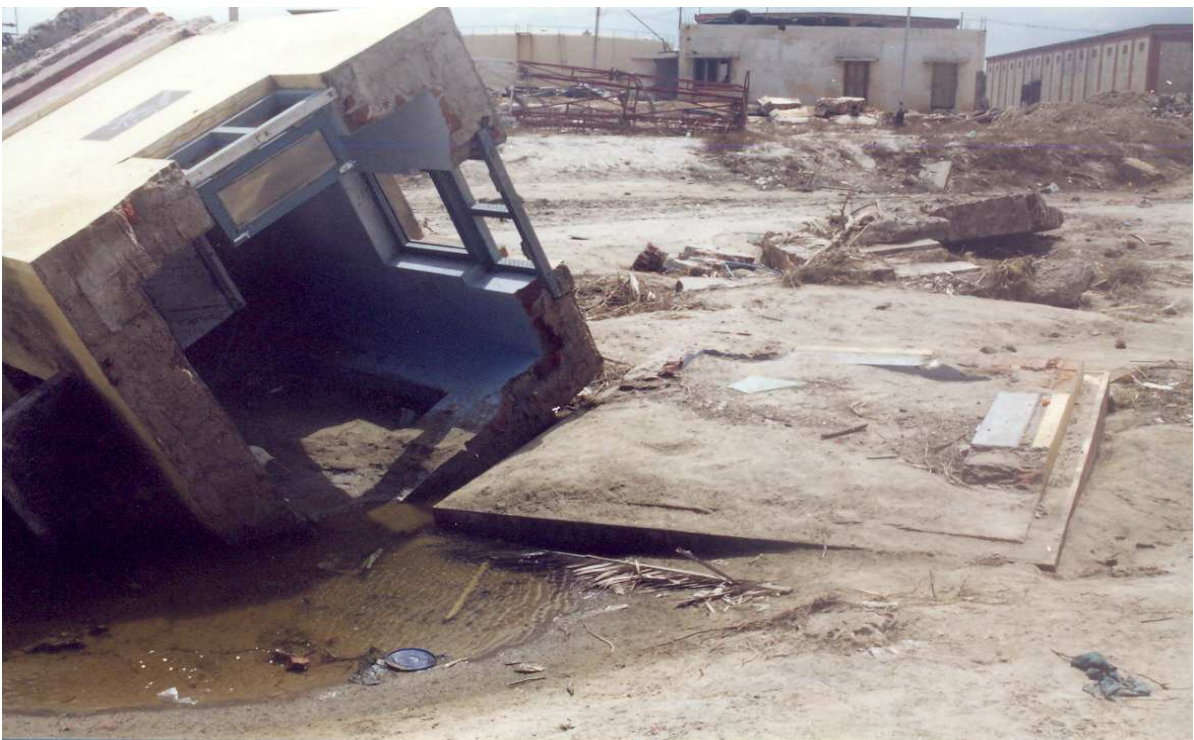
When compared to smaller and isolated structures stability is more in bigger structures due to structural integrity through more internal and external structural components in the lateral directions. The stability of a structure is more if the increase of structural dimension in the direction of the flow is more than that in the direction perpendicular to the flow. Instances of structural failures due to these effects were found at several locations (Plate 14).

Plate 14. Total failure of isolated and small dimensioned structure in the front and unaffected larger structures in the background (Nagapattinam harbor).

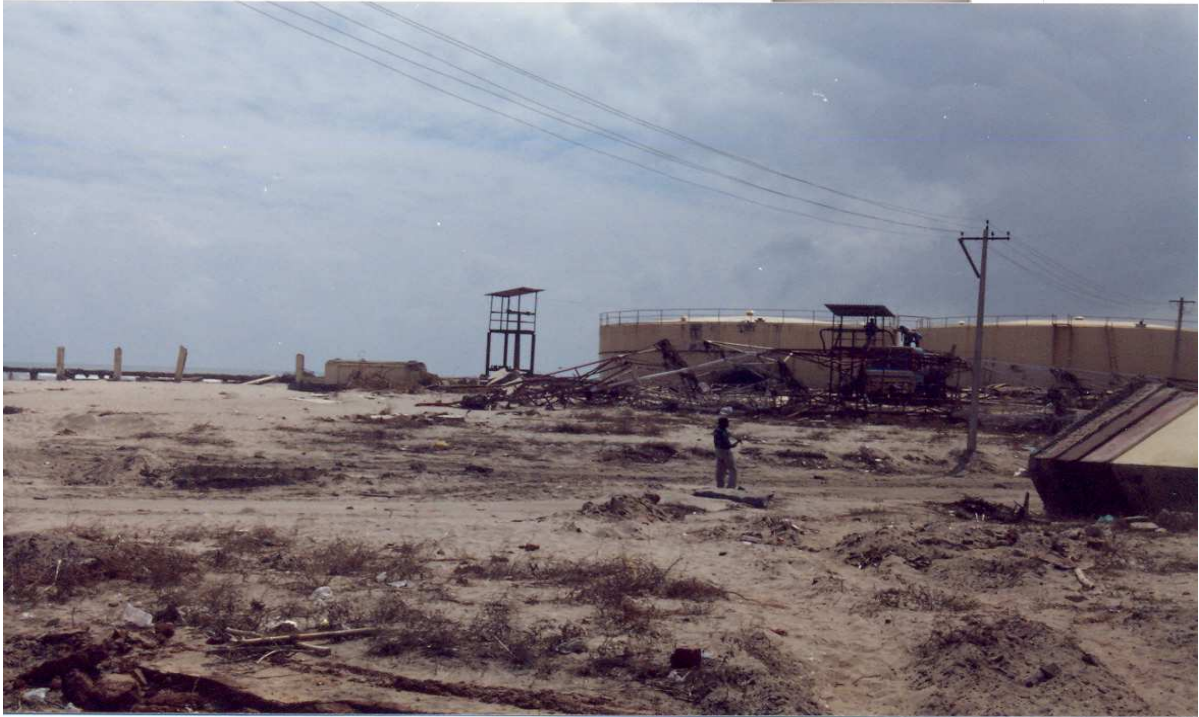
oil storage tank (in the background), which is bigger than the generator room (in the right side foreground), escaped from failure due to tsunami flow. The same way the cylindrical light house structure at Nagapattinam harbour could survive the tsunami attack (Plate 16).

Plate 15. Minimally affected large cylindrical oil storage tanks in the background and the damaged small generator room in the right side (Nagapattinam harbour).

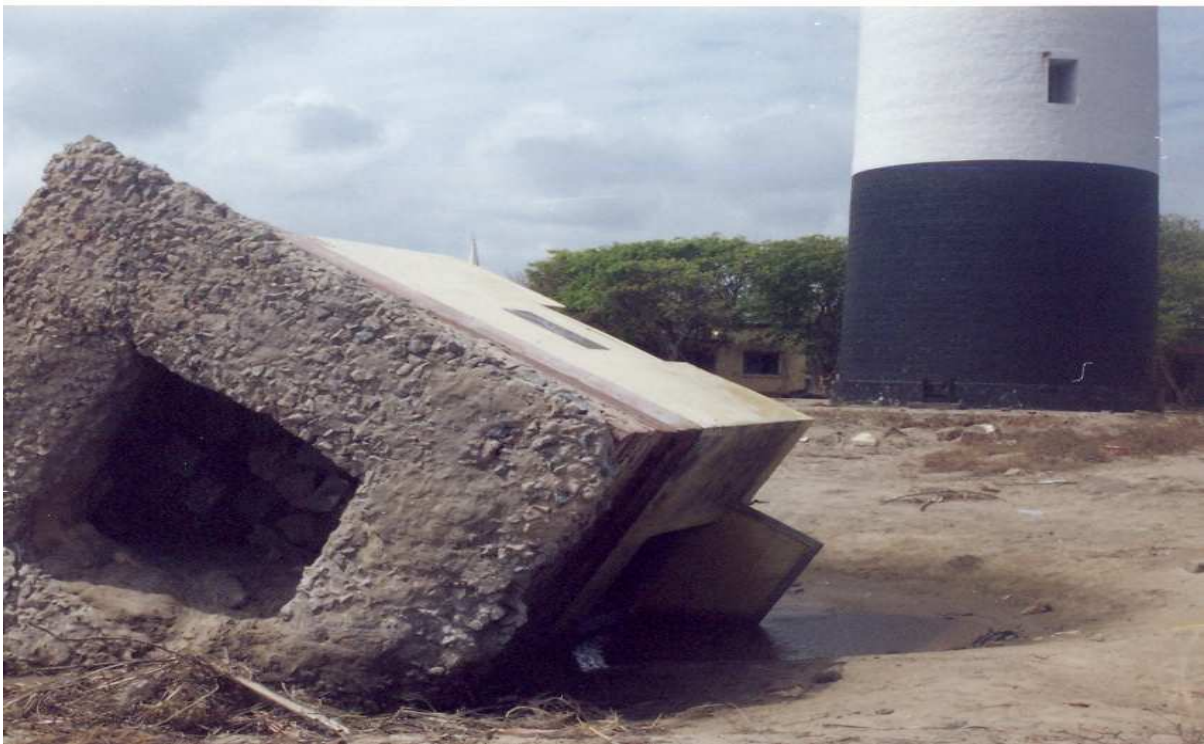
Plate 16. Unaffected light house (circular in plan) at the background and failed structure (rectangular in plan) at the front (Nagapattinam harbour).

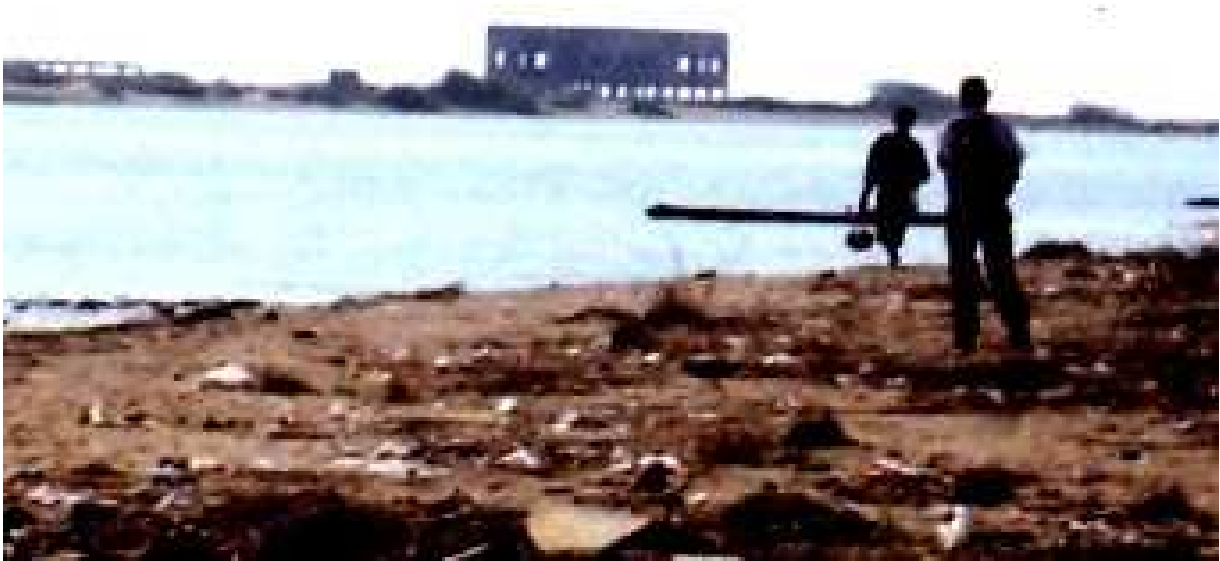
Certain functional structures such as office buildings of port/harbor, customs, fisheries and other navigation related office buildings need to be always closer to waterfront. Such concrete structures very near to sea made transparent to certain degree by stilt construction with sufficiently deeper column foundations could withstand flow of tsunami waters. For example the Plate 17 shows such a structure which is right on the beach and survived the tsunami attack.

Plate 17. A concrete structure on stilts built right on the beach but remained unaffected by tsunami (Tirumullaivasal).

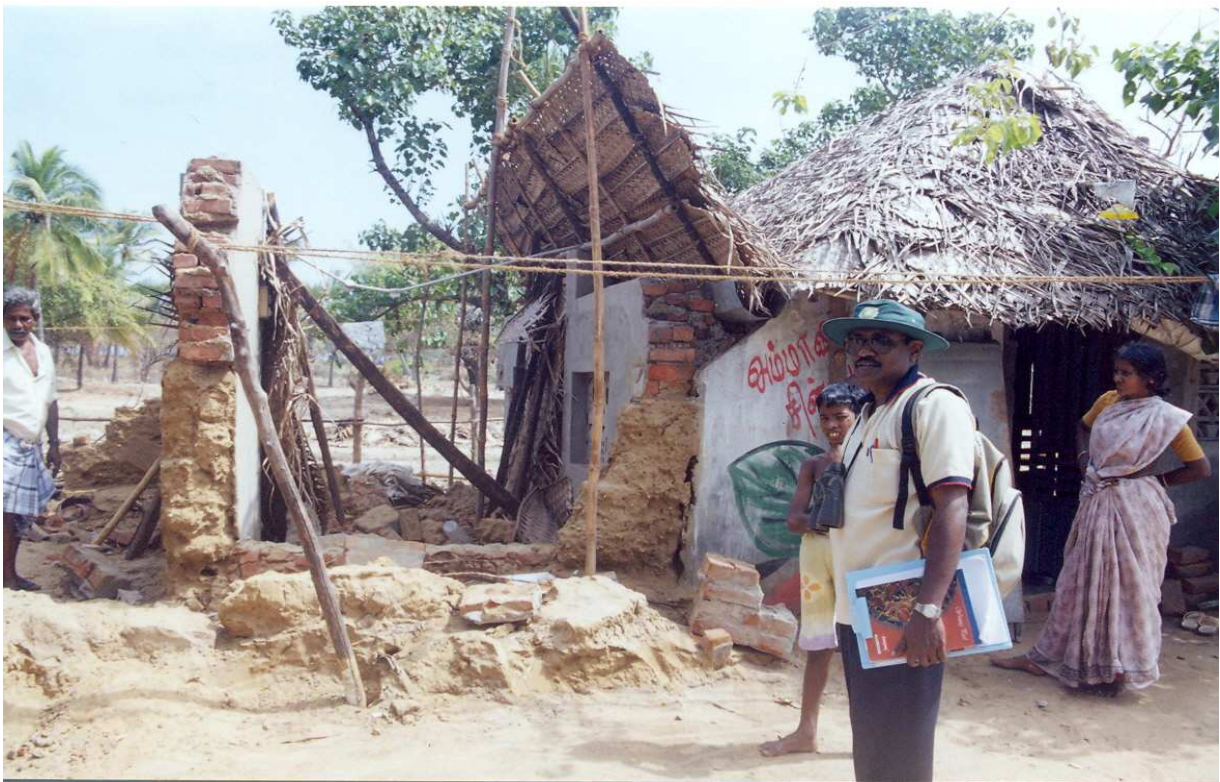
In many locations mud plasters were used for binding the burnt bricks in the walls (Plate 18) and hence walls collapsed by inundation waters of tsunami. It has been noticed, that structures at many locations were of poor quality due to non-engineered construction practices. Even many damaged houses with concrete

Plate 18. Failed mud plastered brick house (Velankanni).

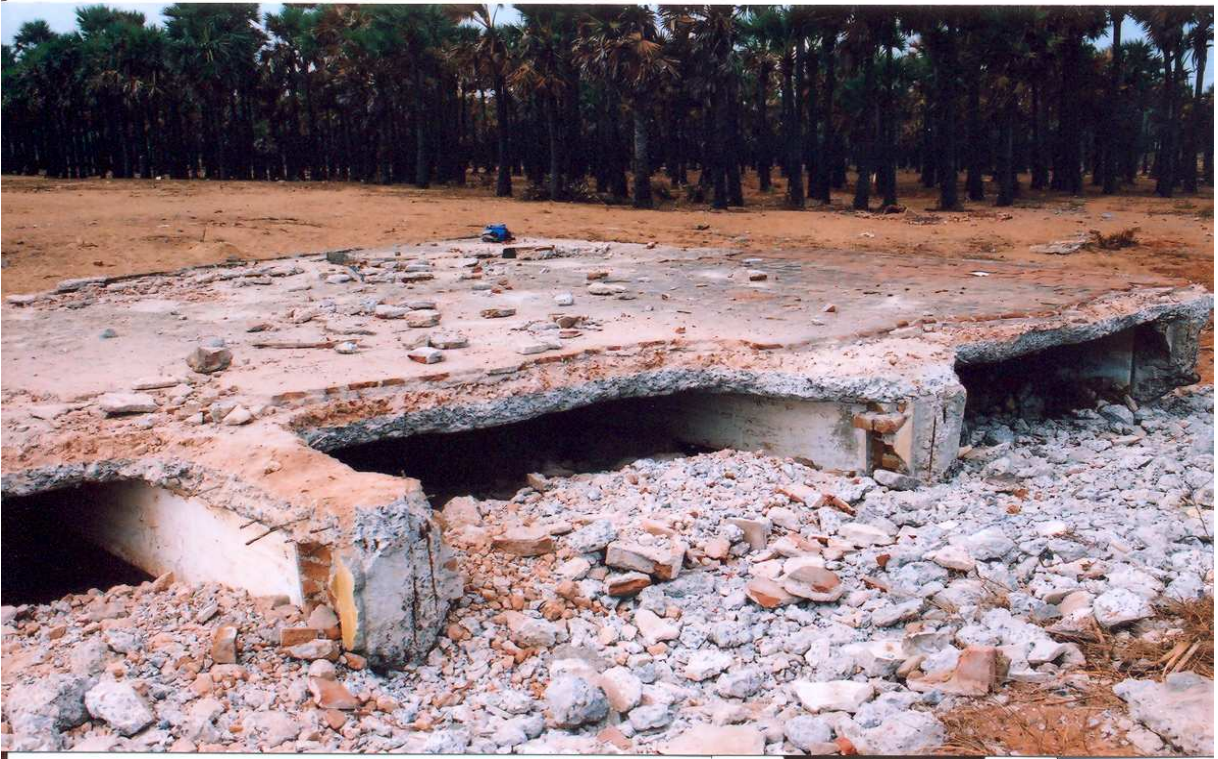
structural members were found to have been built by local people without appropriate engineering planning, design and supervision (Plate 19).

Plate 19. Failed concrete structure (Roof) built with poor quality construction practices (Periyakalpet).

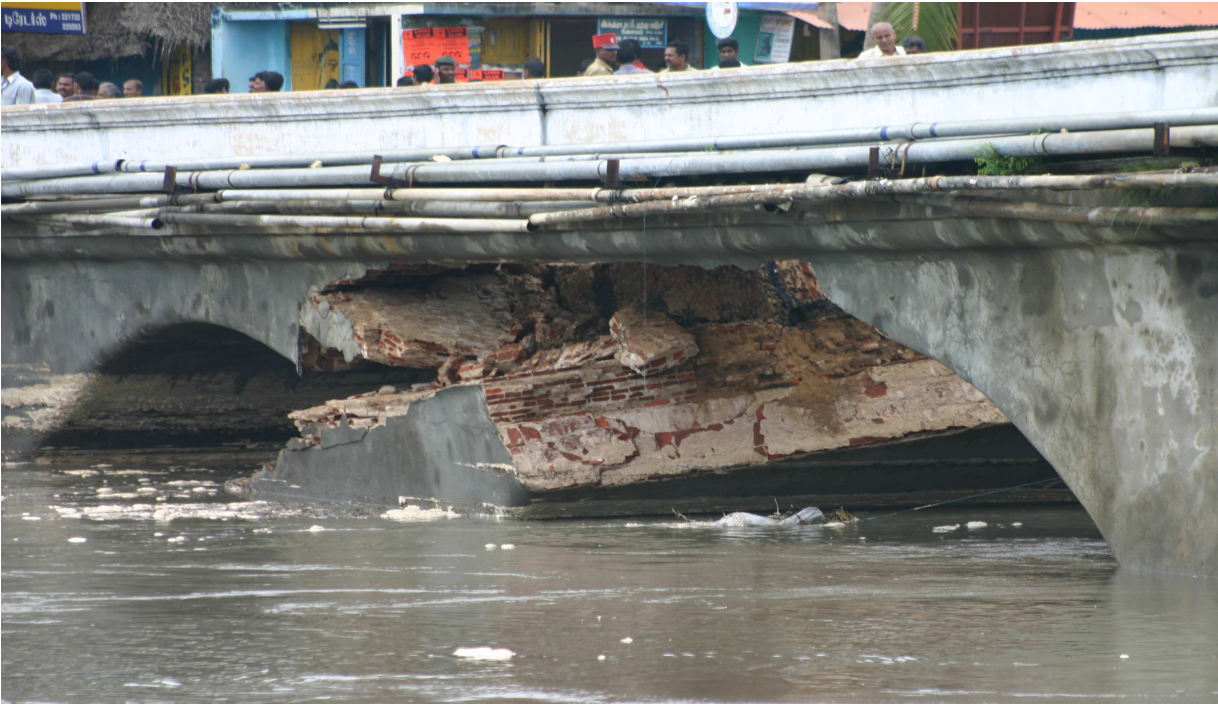
Age old structures are always vulnerable to failure even to small increment of load. Plate 20 shows such an old road bridge made of bricks with lime mortar at Karaikal, where one of the piers got detached from the superstructure due to extensive scour lead settlement and impact of tsunami surges.

Plate 20. Example of scour failure in one of the piers of very old arched road bridge constructed with brick in lime mortar (Arasalaru river bridge, Karaikal).

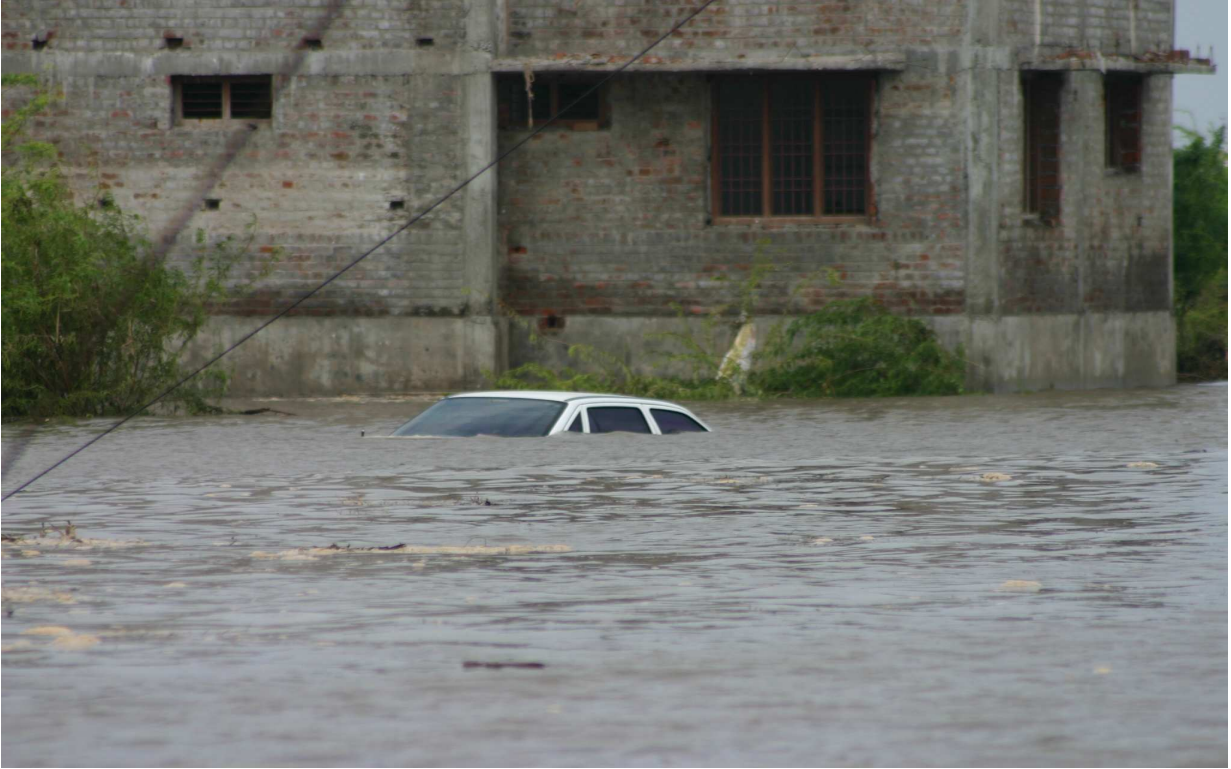
Plate 21. Example of unaffected house built on elevated plinth in the low lying areas (Karaikal).

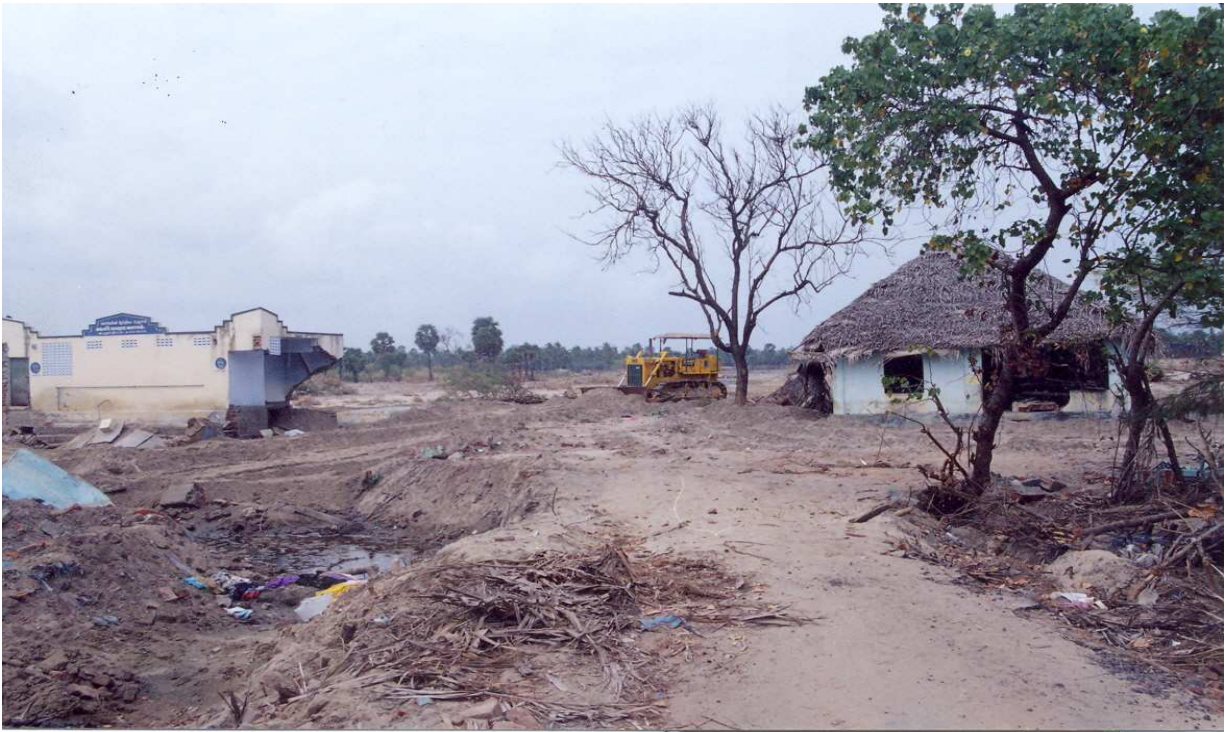
Structures in the low lying area can be subjected to severe and complex flow conditions around them causing failure. For example, some structures (Plate 22) at Velankanni, Nagappattinam and Nagore which were considerably away from the sea were affected by lateral tsunami flow through nearby creeks and streams and had foundation failure due to severe and complex flow around them.

Plate 22. Example of failed structure constructed in lower level (Left) as compared to the unaffected house (right) constructed on higher ground level (Velankanni).

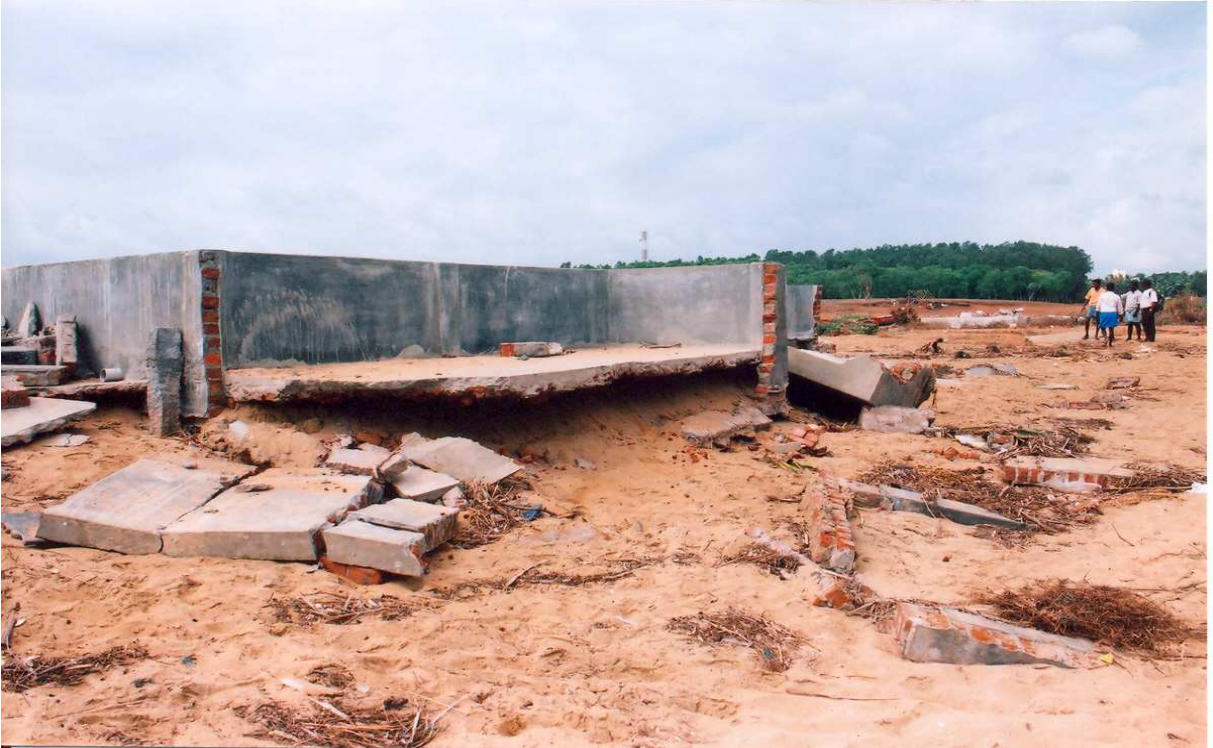
Type of soil available at the site for the foundation plays an important role in the stability of foundation. Loose sandy soil is vulnerable with respect to erosion/scour. Soft clayey soil leads to settlement failure of the structure on longer exposure to inundated waters. Such instances of foundation failure due to erosion of loose sandy soil by tsunami flow were found at places (Plate 23).

Plate 23. Tsunami damaged structures founded on loose sandy soil (Periyakalpet).

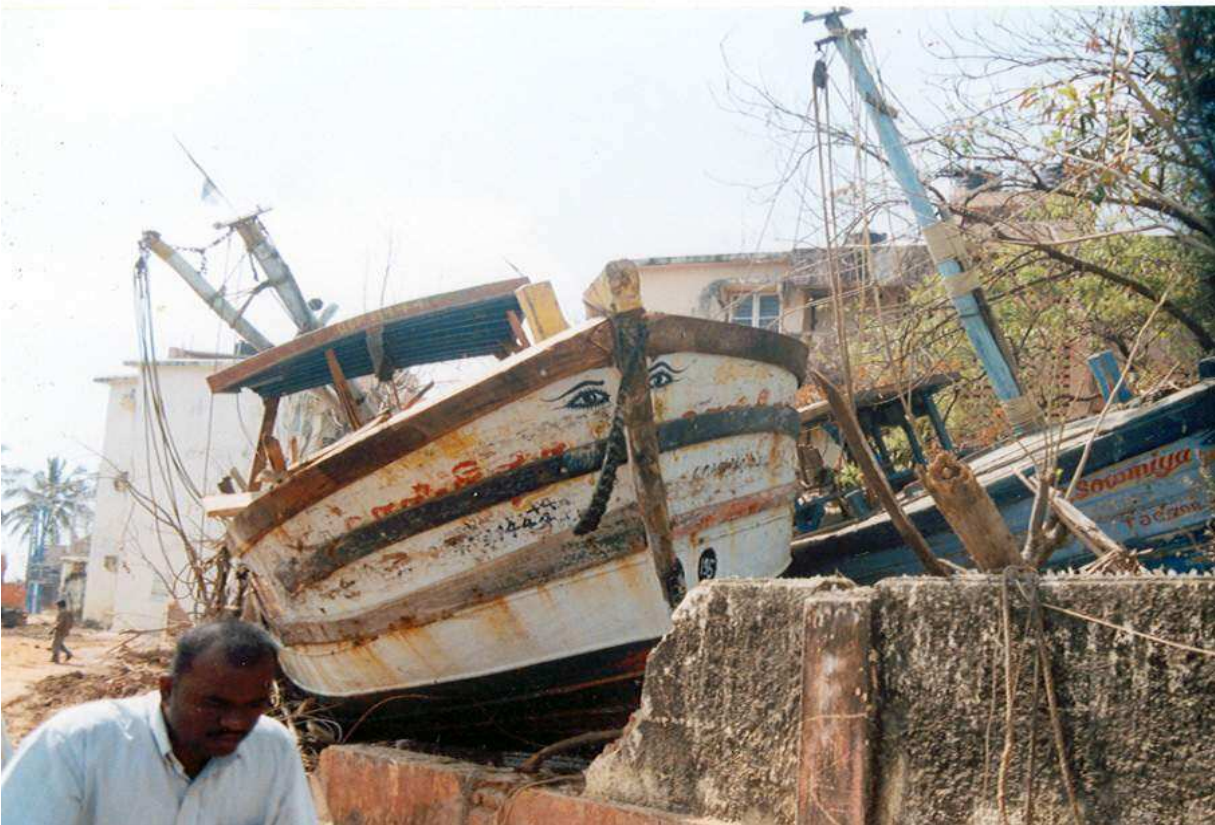
Uplifted boats, or similar floating marine vessels and washed away motor vehicles on land cause damages to nearby structures by direct collision. The structures close to port/jetty and coastal road networks and vehicular parking area are vulnerable to such damages. Plate 26 shows the uplifted fishing vessels taken much interior on land side by tsunami which caused heavy damages to the nearby structures.

Plate 26. Structures damaged by uplifted fishing trawlers (Nagapattinam).
