BIOFOULING AND CORROSION ON WAVERIDER BUOY SYSTEMS

ABSTRACT

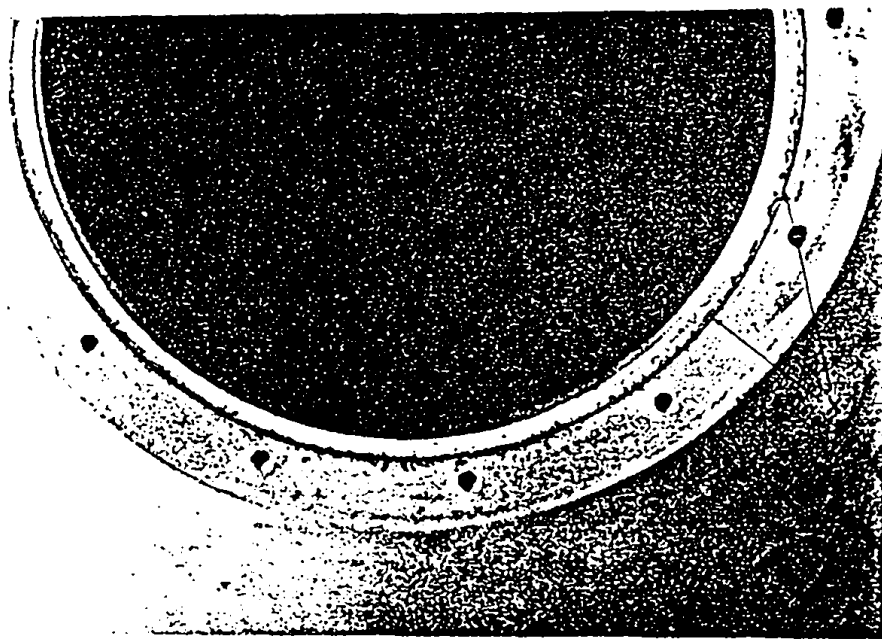
A new unused 90 cms diameter waverider buoy made of type 316 stainless steel hull was operated continuously for a period of eight months covering the 1984 monsoon and the post-monsoon period. The lower hull of the 90 cm diameter waverider buoy was left unpainted as per the recommendations of the manufacturer (M/s Datawell, Netherlands), While the upper hull was painted in deep orange colour by using ordinary synthetic enamel paint for improving the visibility of the buoy from a distance. The localised crevice and pitting corrosion at two locations was noticed on the waverider buoy. They were at the O-ring groove of the hull (Fig. 3) and on the lower hull as well as at the rubber fender on the upper hull of the waverider buoy.

FIG.3. X CORROSION PITS ON O-RING GROOVE.

The first type of marine corrosion was probably as a result of the trapping of the seawater in the O-ring grooves. Application of sealants like silicon grease did not prove to be effective to prevent the seawater seepage through the fine cracks of O-ring. The second type of marine corrosion was noted to be more dominant on the lower un-painted hull of the waverider buoy. On recovery, a fairly large growth of marine foulers (Fig. 4) on the lower hull of the buoy was observed. Crevice corrosion initiated in these numerous interstices caused by the marine foulers probably has led to severe pits on the hull. These pits were of scallop shape with penetration into the hull varying from 40% - 50% of the buoy hull thickness. The protective coating of paint on the upper hull was not found to adhere on to the smooth stainless steel surfaces. The trapped

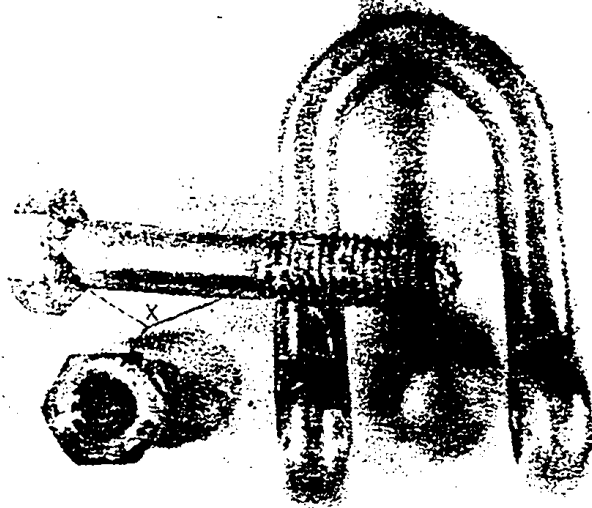
The D-type shackles made of 316 stainless steel used for connecting the rubber cord to the waverider buoy was also found to be severely pitted (Figs. 6 & 7) in the crevice formed between the locking bolt head and its mating U-body area of the shackle, in the crevices formed between the locking nut and its mating U-body area of the shackle as well as in the crevices formed between the threaded contact surfaces between the locking nut and bolt. The depths of the pits formed varied between 3 to 5 mm.

FIG. 6: X CORROSION OF 316 S.S. SHACKLE.

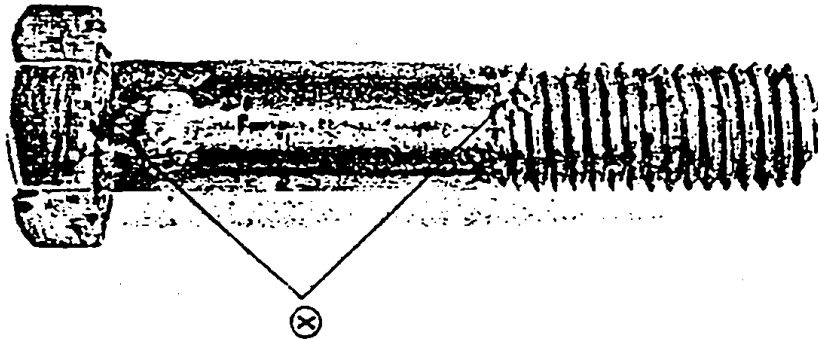
FIG. 7. X CORROSION ON 316 S.S. SHALKLE BOLT

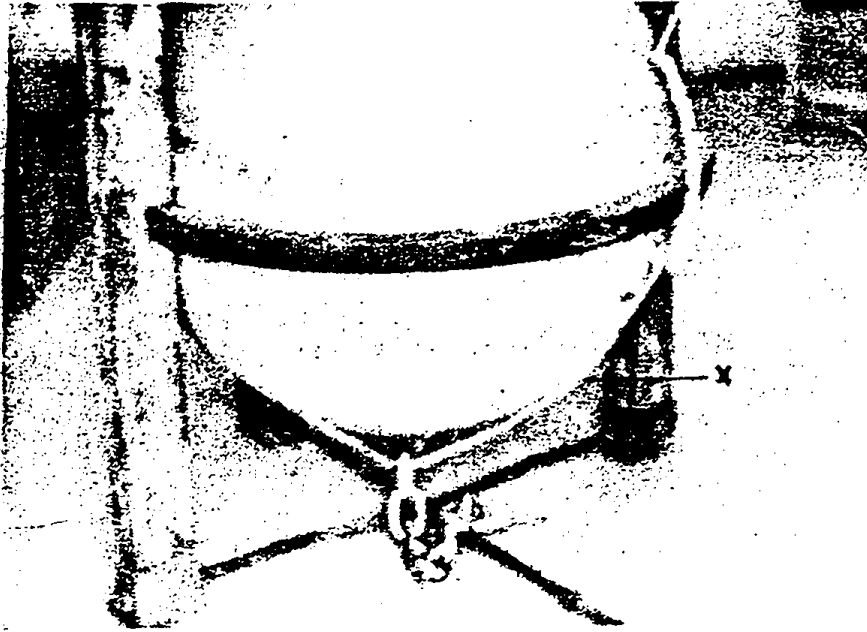
FIG. 8. X CORROSION OF WELD DEPOSITS AROUND EYE.

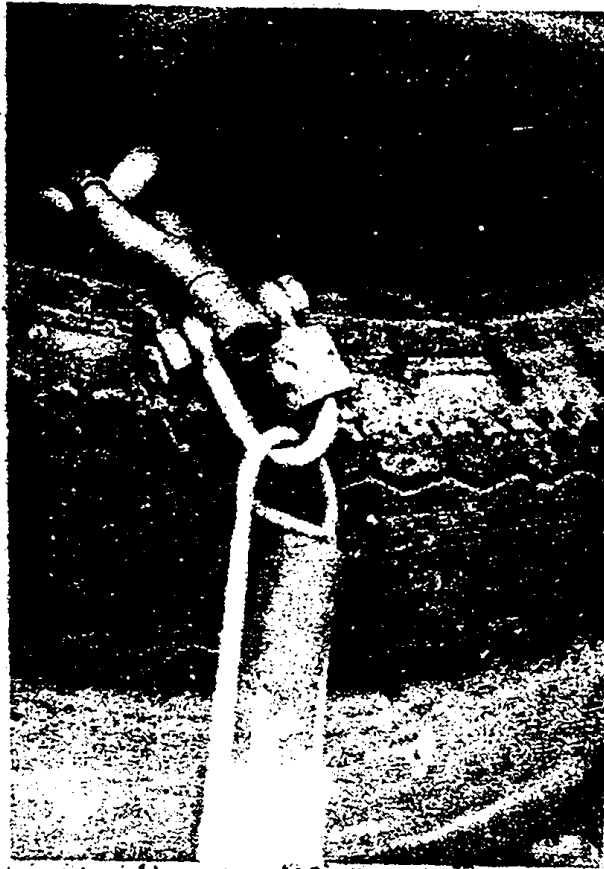
FIG. 11. X SACRIFICIAL ZINC ANODE
PROVIDED ON 316 S.S. SHACKLE.

It is recommended to use type 316 stainless steel hardwares in the mooring. If galvanised steel components are used in the mooring necessary allowance to cover the corrosion losses has to be provided. Fig. 11 shows cathodic protection used at N.I.O. on type 316 stainless steel D-shackles by clamping a zinc sacrificial anode.
