NIO'S EXPERIENCES IN DATAWELL WAVERIDER BUOYS

S. G. DIWAN, A. K. SURYAVANSHI & B. U. NAYAK
National Institute of Oceanography
Dona Paula, Goa-403 004

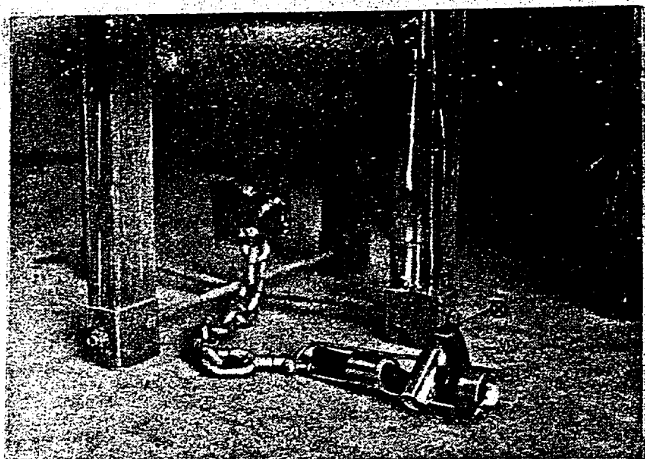
This type of failure had occurred a couple of times during the recovery of waverider buoy and its mooring using offshore supply vessels at Bombay High. The waverider buoy was hauled up on the boat deck while its mooring anchor was still on the sea bed. The boat used for recovery operation started drifting away from the buoy station due to strong surface currents prevailing in the area during this operation. The supply vessel could not be manoeuvred properly and this caused the rubber cord to stretch beyond its tolerance limit. This led to the rubber cord pulling out from its upper stainless steel end fitting connected to the waverider buoy stabilising chain, causing the loss of the full moorings.

FIG. 3 ⊗ - BROKEN RUBBER CORD END

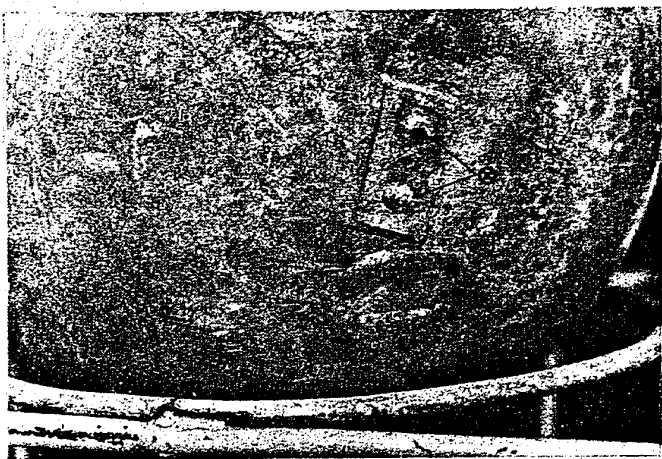
FIG. 4 ⊗ - BROKEN U-EYE FOR STABILIZING CHAIN.

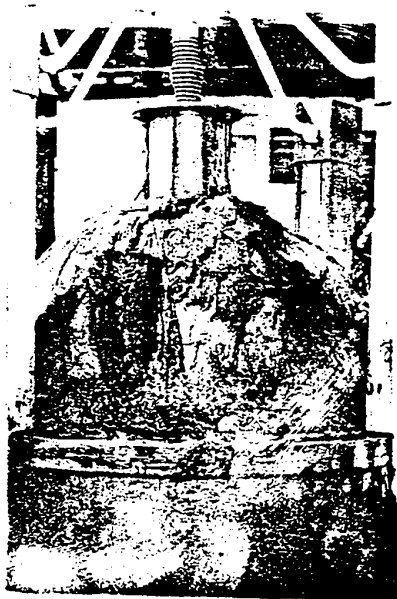
During the periods of heavy flood water discharge in the Godavari basin causing strong currents at the buoy location off Kakinada, the waverider buoy used to submerge frequently. In a few occasions plant bushes carried by river water got entangled with mooring line resulting in high drag on the buoy and subsequently submerging it partially. The free floating ability of the buoy was restored after separating the entangled bushes from the waverider buoy mooring. On a few occasions, heavy growth of algae on the waverider surface and huge colony of barnacles grown on the subsurface floats (Fig. 5) were observed off Kakinada. Such growth was also responsible for partial submergence of the buoy during periods of strong

FIG. 5 BARNACLE GROWTH ON
SUBSURFACE BUOY

AND

ALGAE GROWTH ON
WAVERIDER HULL

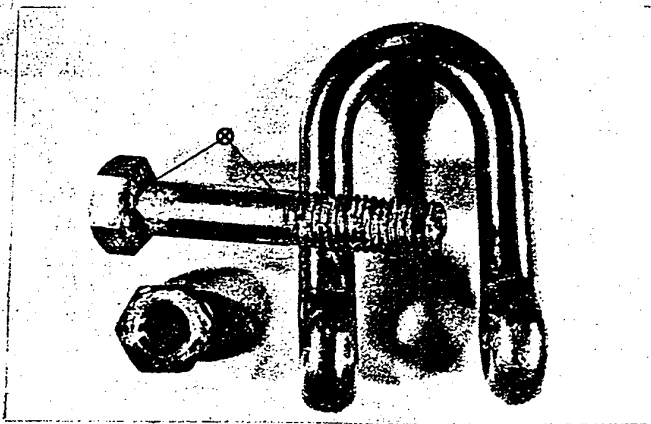
The 316 stainless steel D-type shackle used in the mooring line of a buoy deployed off Uran was found severely pitted (Refer Fig. 7). Corrosion attacks were generally around the threaded part of the shackle bolt and in the crevices formed between the bolt head and body of the shackle. The corrosion on 316 stainless steel waverider hull was suspected to have occurred due to penetration of sea water under the pinholes in the painted hull surface and also due to growth of barnacles over it, which properly initiated crevice corrosion leading further to severe pitting.

FIG. 7 - CORROSION OF 316 S.S. SHACKLE

(3) Regular checking and redeployment of the mooring at an interval of 6 to 9 months ensures long-term wave data collection with minimum of interruptions. Replacement of the whole mooring at the time of redeployment is desirable to avoid failure of the mooring due to corrosion fatigue.

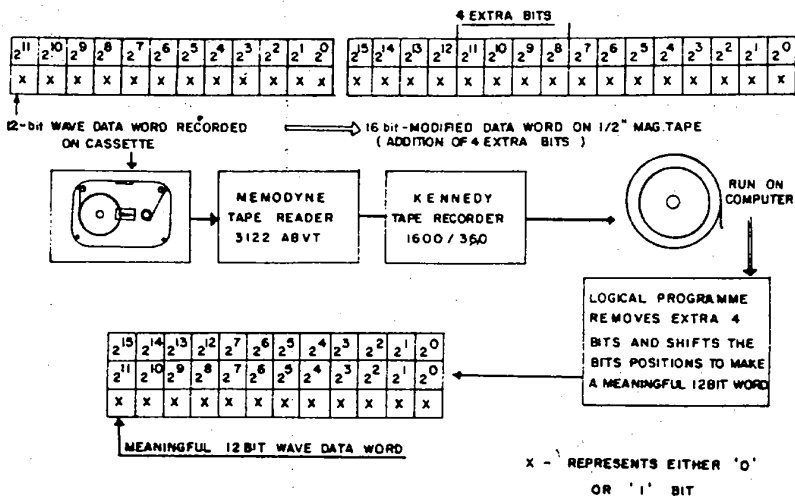
binary word. When this cassette is run on Memodyne Tape Reader 3122 ABVT interfaced to Kennedy Incremental Tape Recorder, 12 bit word is modified to 16 bit word in which 4 extra non-significant bits are added. This 16 bit data word is written on the 1/2" magnetic tape by Kennedy Incremental Tape Recorder. While using this data for computer analysis the 4 extra bits have to be removed so as to retrieve the original 12 bit wave data word. This logical problem was solved on TDC 316 mini computer as explained in Fig. 8. The same logic was applied on DEC 10 computer to convert the raw data of 16 bit word length to desired 12 bit wave data. After solving this problem, the collected wave data could be analysed using software program NEPTUN on DEC-10 computer.

FIG. 8 METHOD OF 12 BIT DATA WORD RECOVERY.
