Operational experiences of Datawell waverider buoys*

S.G. DIWAN**, A.K. SURYAVANSHI** and B.U. NAYAK**

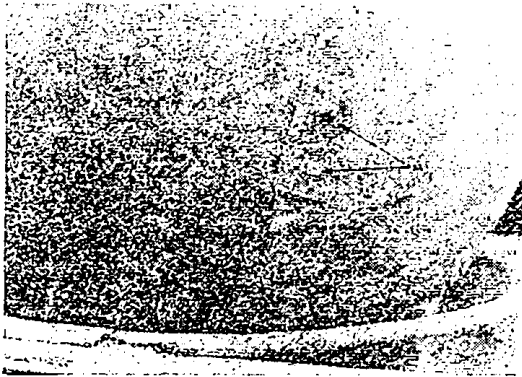
Fig. 4. Failure of U-eye on bottom of waverider buoy 'A'.

4. Failure of the bottom U-eye of waverider buoy (Fig. 4)	The buoy was drifted to shore & the U-eye was broken by the local fisherman while removing stabilising chain.	Measures are underway to weld a new U-eye to this waverider buoy.	This is a rare problem and has happened during the wave measurements off Daman.

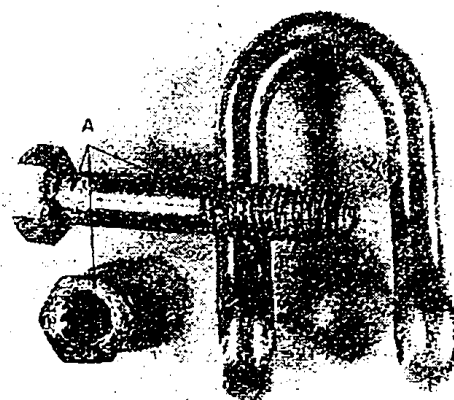
Fig. 6. Corrosion of D-type st. steel 316 shackles (A).

2. Crevice corrosion of D-type 316 st. steel shackle	Formation of oxygen concentration cells in the crevices between U-body, bolt & nut (Fig. 6).	The design of D-shackle is modified, in which the bolt has enough play in the axial direction after tightening the nut. In few instances, zinc sacrificial anodes were clamped to the shackle (Fig. 7).	The modified D-shackles worked satisfactorily.
