**An environmental perspective of post-tsunami scenario along
the coast of Tamil Nadu, India: role of sand dunes and forests**

Antonio Mascarenhas*, Seelam Jayakumar

National Institute of Oceanography, Dona Paula 403004, Goa, India

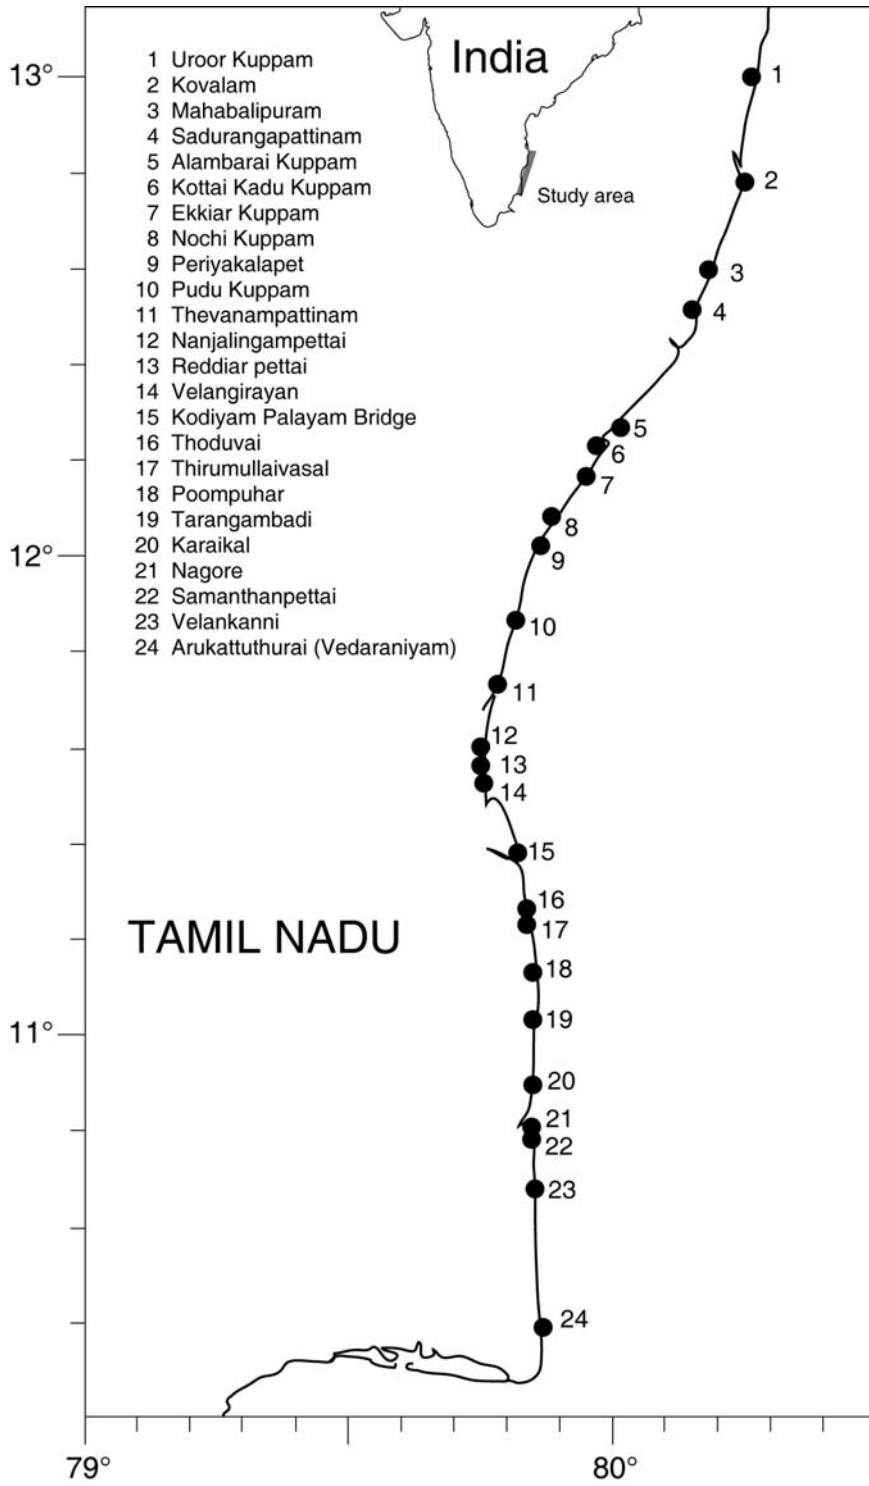
Fig. 1.

After the December 2004 tragedy, the National Institute of Oceanography, Goa, conducted a survey along the Tamil Nadu coast of India (Fig. 1). Various evidences were documented in January 2005. This effort was continued in April 2005, October 2005 and January 2006. A national workshop organized in February 2005 proposed a science plan for hazard preparedness (Krishna, 2005b).

Post-tsunami surveys were carried out along the coast of Tamil Nadu from Chennai in the north to Vedaranyam in the south. A total of 24 major locations were investigated (Fig. 1). Several other intervening sites (not shown in Fig. 1) were also studied. The survey consisted of ascertaining the inundation limits, run-up heights at different locations and measurement of cross section profiles. Damage to coastal dwellings and impact on vegetation was also assessed.

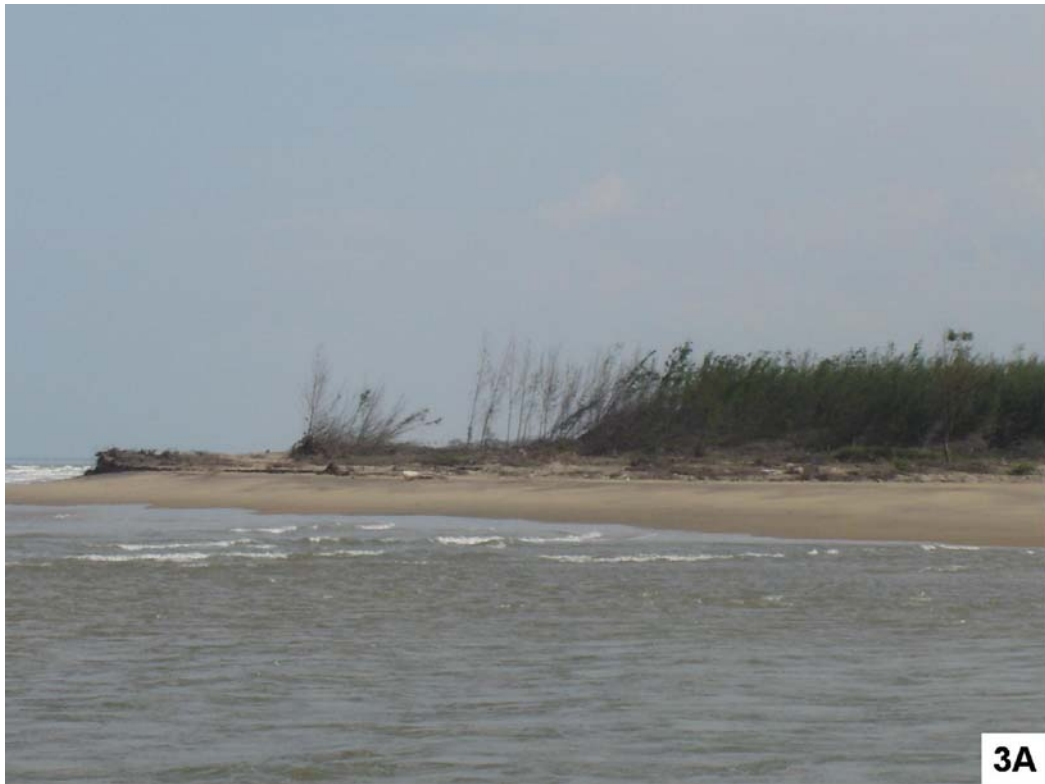
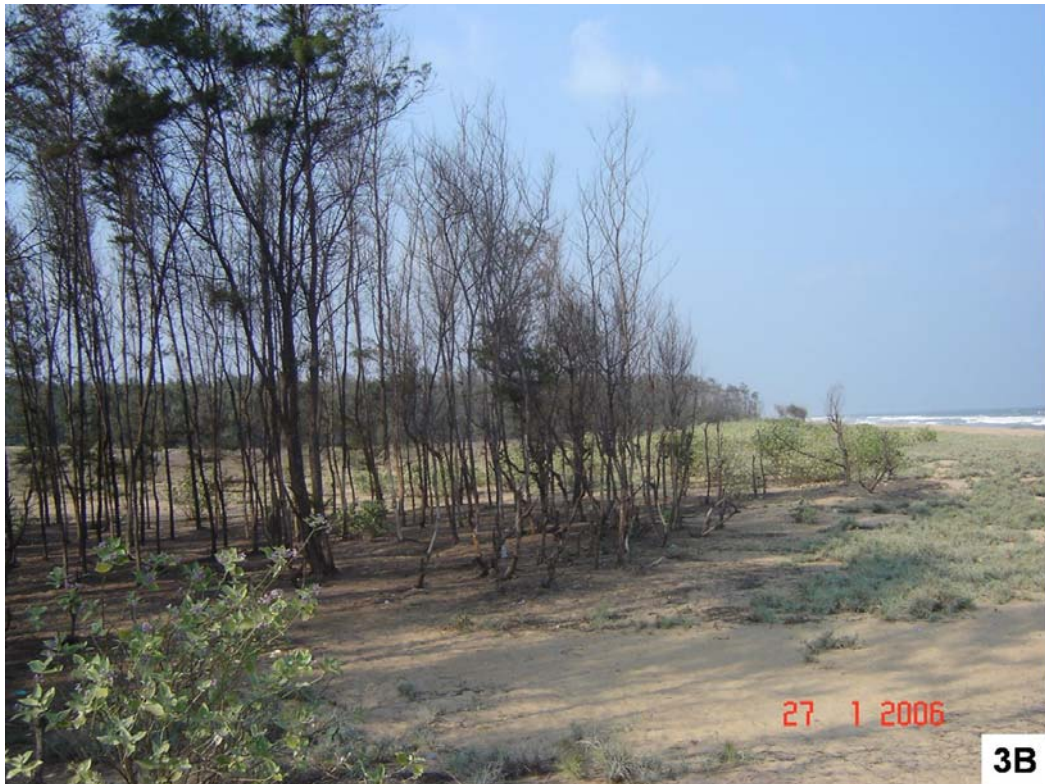
Fig. 3.

Large stretches of Tamil Nadu coast are marked by luxuriant casuarina forests. Thickly vegetated stretches displayed exceptional resilience by dissipating high waves. Field measurements reveal that only the frontal strip ranging from 0 to 25 m were twisted, bent and stripped of leaf cover (Table 3). The average width of damaged trees equals 14 m for a stretch of coast where the wave run-up was as high as 6.5 m above sea level. Only a few trees that faced the open ocean were uprooted and hence suffered the most (Fig. 3). At some places however, casuarinas were hardly affected.
