Study of Goa and its Environment from Space

Coastal Sand Dune Ecosystems of Goa :
Significance, Uses and Anthropogenic Impacts

March 1998

ANTONIO MASCARENHAS

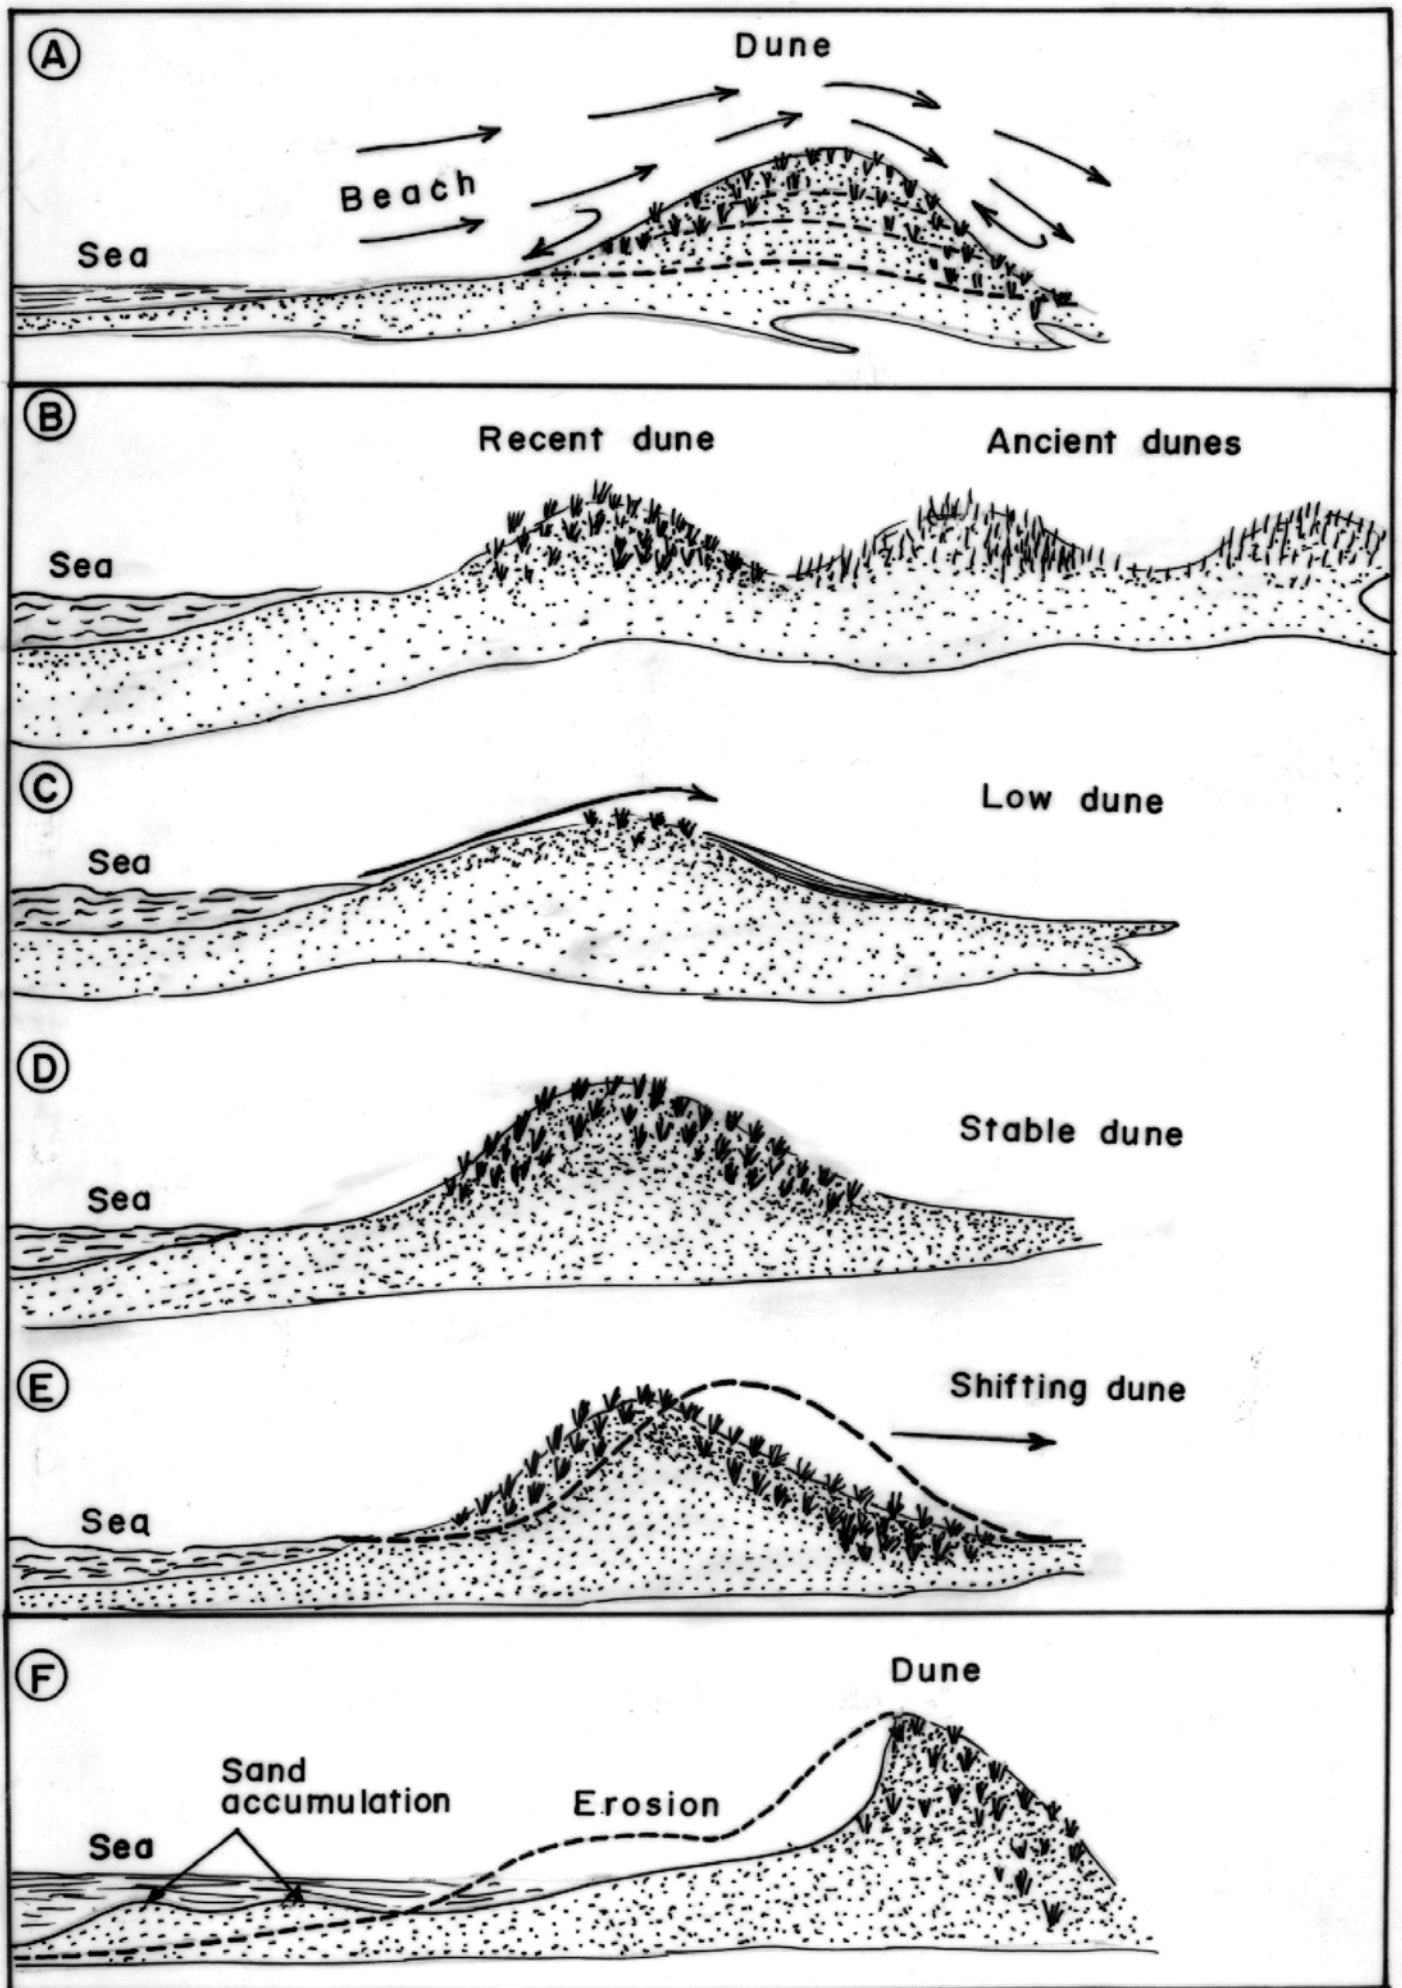
FIGURE -2

Figure 2: Formation, spatial evolution and natural behavior of coastal sand dunes on a geological time scale, under various environmental conditions such as the availability of sand and the state of sea level (modified from Paskoff, 1989; see text for explanation).

- 2B: A new dune forms seaward of earlier ones, now inactive, under lower sea level conditions when the sand budget is positive;
- 2C: No significant dunes can form under rising sea levels as the sand is washed over (arrow) due to a negative sand budget;

- 2D: Stable, vegetated and high dunes occur under stable sea level conditions due to a perfect coastal equilibrium;
- 2E: Sand dunes tend to migrate under stormy sea conditions which also lead to shifting of coastlines, an important criteria for coastal zone management;

The evolution of a coastal dune system strictly depends on the sedimentary budget of the beach which refers to the relation between the quantity of sand brought in by winds and the sand removed by tides and littoral currents. Their evolution is also dependent on the conditions of the sea level which can be stable, or in increasing or decreasing mode. Based on the above criteria, four major typical models can be proposed (see Figures 2B - 2E):

When the sea level decreases, the subaerially exposed beach area increases; the sand budget is positive and hence the beach progrades and advances towards the sea (Figure 2B). The surplus sand that is available forms a new sand dune seaward of the

When the sea level rises, beaches are flooded due to which they narrow down and thin out; thus, the sand budget is negative. In such a case there is hardly any possibility for the formation of new dunes; only a low berm with minor vegetation is normally found (Figure 2C). In such situations, high waves often wash over the dunes and is accompanied by erosion of the sand body.

The above models depict various stages of sand dune evolution and hence the evolution of the coastal landscape on a geological time scale, depending upon the environmental conditions. However, it is the model shown in Figure 2E which should generally be applicable at present, considering the fact that the global sea levels are on the rise. This criteria has to be considered and be given due importance in the planning and management of open sea fronts; these aspects are elaborated in the later parts of this report.

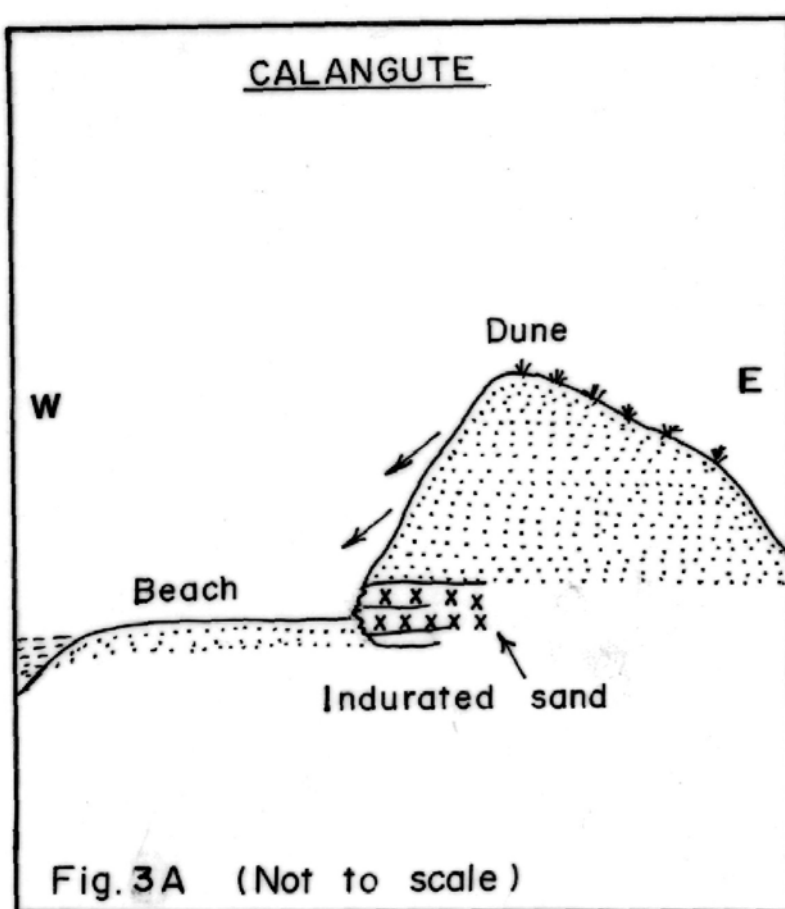
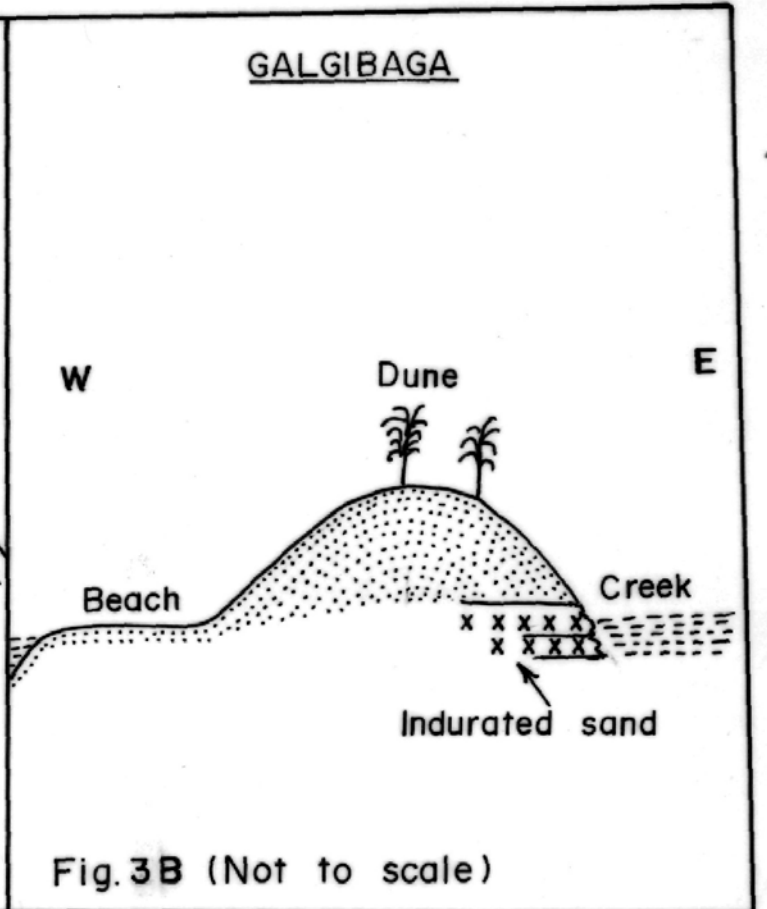
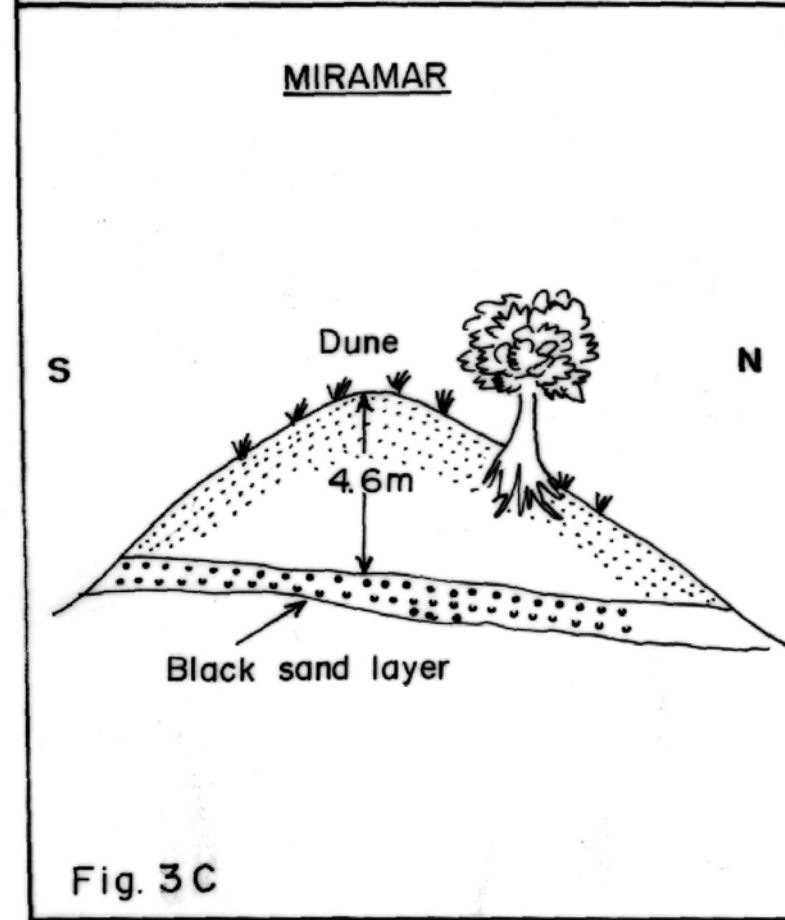
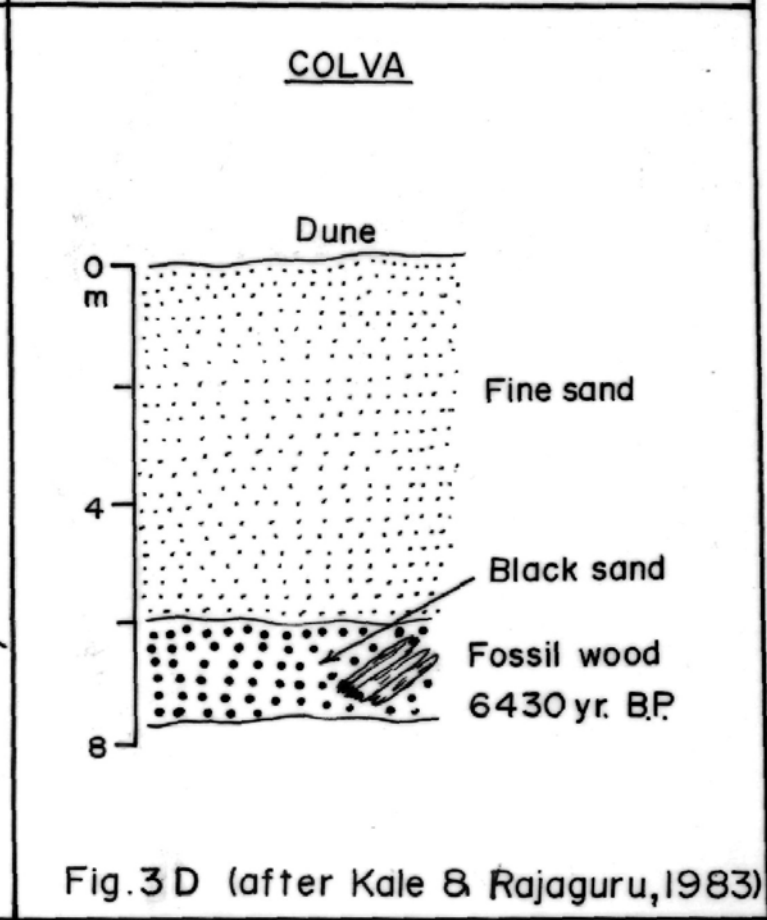
FIGURE - 3

- 3 A: Calangute - a high dune, the sea face of which is degraded due to human interference; a consolidated body, exposed due to wave action, underlies this dune; a part of this rock (age not known) presently lies above sea level;
- 3B: Galgibaga - an indurated sand body which underlies a stable dune is exposed along the creek;
- 3C: Miramar - cross section of a sand dune which has been mined shows the presence of a black sand layer dipping towards the river;
- 3D: Colva - fossil wood found 7 meters below a dune has been dated at 6430 years BP; the dune sand was deposited subsequently.

The temporal evolution and geological history of the sand dunes of Goa has never been studied in detail; but some pertinent facts are mentioned here (Figure 3). At Miramar, our unpublished data (Figure 3C) of two vertical sections (one of a dune and the other a road trench) indicate that, from the top downwards, the sediment is exclusively composed of medium sands only. The section shows colour contrasts in various shades of yellow evidently related to the climates which prevailed during the past. The most prominent feature of this section is the occurrence of a seam of black sands near the base of the sequence. This black layer rich in heavy minerals, about 10 to 30 cm thick, shows irregular but sharp top and bottom contacts (unpublished data). Detailed field observations revealed that this black sand layer has a significantly wide spatial distribution as it is found to extend from Campal to Miramar and even further to Caranzalem and Dona Paula; this layer thins out within a kilometer towards the hinterland. A similar black layer intercalated within dune sands has also been observed at Velsao. In the entire area, the black mineral seam is found at different depths from the surface.

Similarly, at Galgibaga river mouth, an indurated sandstone outcrop, resembling a beach rock, was identified at the base of a sand dune (Figure 3B). As this consolidated material was also found at another place in the vicinity, this rock

appears to underlie the entire dune of the area. A similar rock type was also identified at the base of a dune north of Calangute (Figure 3A); the type and nature of this rock has not been ascertained yet.

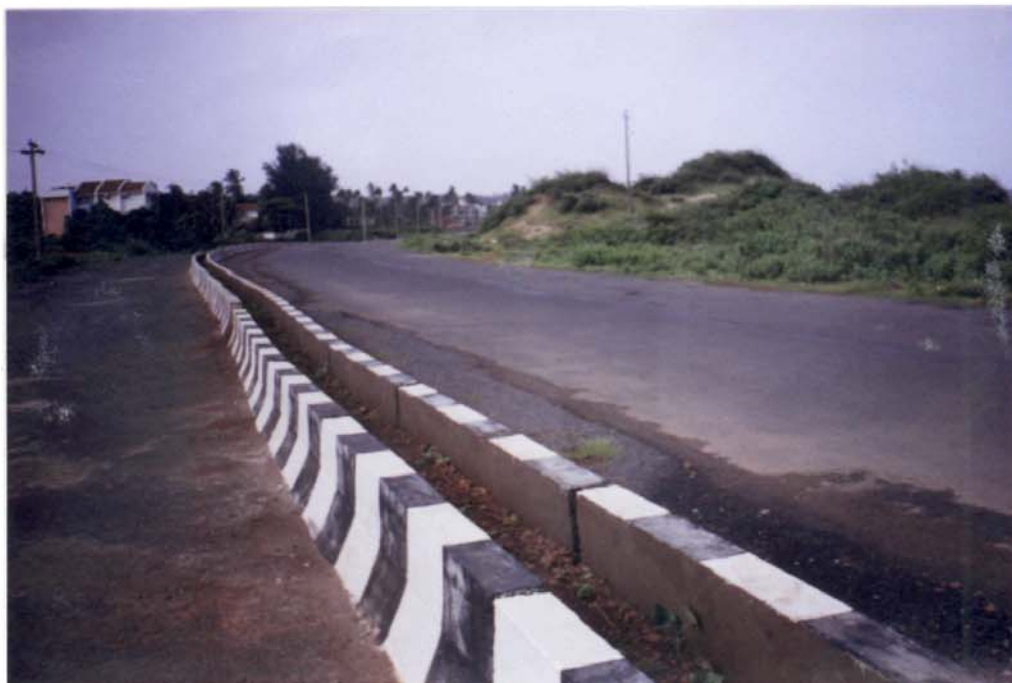
9

- Figure 9: Miramar - A new broad road laid over a dune belt; sand deposits are now observed on this road at several points due to the desecration of dunes thus generating mobile sand (January 1998).

As a typical example, the Miramar circle which was built about more than 100 years ago can be cited as a human failure. It has been observed over the years that during windy days in summer, large quantities of dry sand are blown inland and can be felt as far as Tonca. This can be experienced by anyone who stands there as sand grains sometimes rise to knee level. The small beach which is excessively used is devoid of dune vegetation and therefore bare in most of the area. The result is that the Miramar round-about and the radiating roads are covered by sand for most part of the year, creating dangerous road conditions for traffic. This is due to the imbalances in the sand budget wherein the sand which has been rendered mobile, tries to find equilibrium and comes to occupy its rightful place: the circle, now located on former sand dunes. Unfortunately, instead of dumping the sand back on the beach so that the latter can recuperate, the authorities collect sand in trucks and dump it elsewhere (and is even sold by unscrupulous elements to the building industry).

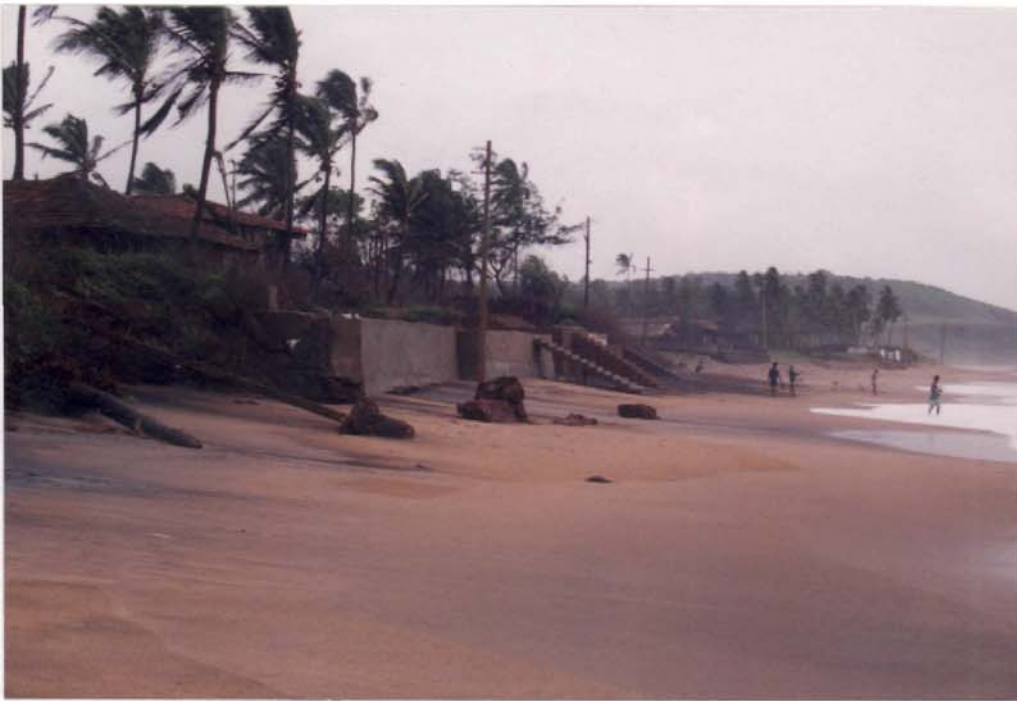
14

- Figure 14: Anjuna - Blatant violations of CRZ laws as this structure is located along the HTL, almost in the water at high tide; as a consequence, significant localised erosion can be identified on either side (August 1996).

Anjuna (village): Several new structures including houses are erected on the dunes and also along HTL partly on the beach (Figure 14); shoreline erosion is observed, electric poles are uprooted; a part of the dune field is intact.

Along the entire goan coast, several structures have been identified on the dunes along the HTL, the most prominent being a resort at Miramar and other smaller ones at Anjuna and Palolem. Excavations and removal of dune sand close to the beach have created deficiencies in the volume of sand. All these sites are precisely the ones where significant erosion has been noted (Figures 8, 13, 14, 15). Although the erosive processes are localized at the moment (except at Miramar), it is found that these hard structures which are in direct contact with marine water are mainly responsible for shoreline erosion, as clearly observed at Palolem. Pertinent details are discussed in later sections.

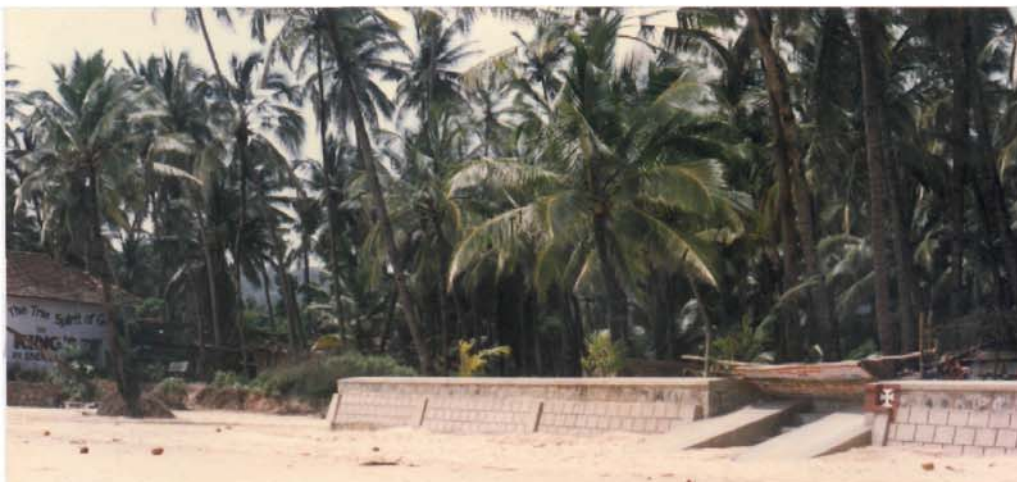
15

- Figure 15: Palolem - A ramp built to allow vehicles onto the beach, an unprecedented CRZ violation along the coastal zone of Goa; severe (man-induced) sand erosion and sea water ingress is observed on either side of this hard structure (August 1996).

Buildings and constructions: Based on our field observations (described above), it is amply clear that there are numerous infringements and irregularities on coastal sandy stretches (Figures 5, 6, 13, 14, 15). The setback lines as stipulated in the notification have been conveniently set aside (Anonymous, 1997,c,d). There are many such cases in the Baga - Candolim sector; the Calangute panchayat has been hauled up for the maximum number of environmental violations (Anonymous, 1996,c). Miramar - Campal area also deserves mention. During the last few years, south Goa dune belts are under assault (Figure 6). The Mobor peninsula which was once declared as a green cover area, has witnessed a frenzied proliferation of resorts which have violated almost all rules stipulated in the environmental guidelines (Anonymous, 1997,b). Our observations show that the latest negative developments are in Palolem where a number of small illegal buildings have mushroomed close to the beach, even on the HTL (Figure 15).
