BEACH CHANGES AT VISAKHAPATNAM DUE TO THE CYCLONE OF MAY 1979

P. CHANDRAMOHAN AND B. PRABHAKARA RAO

*Regional Centre of National Institute of Oceanography,
Andhra University Campus, Waltair, Visakhapatnam-530 003*

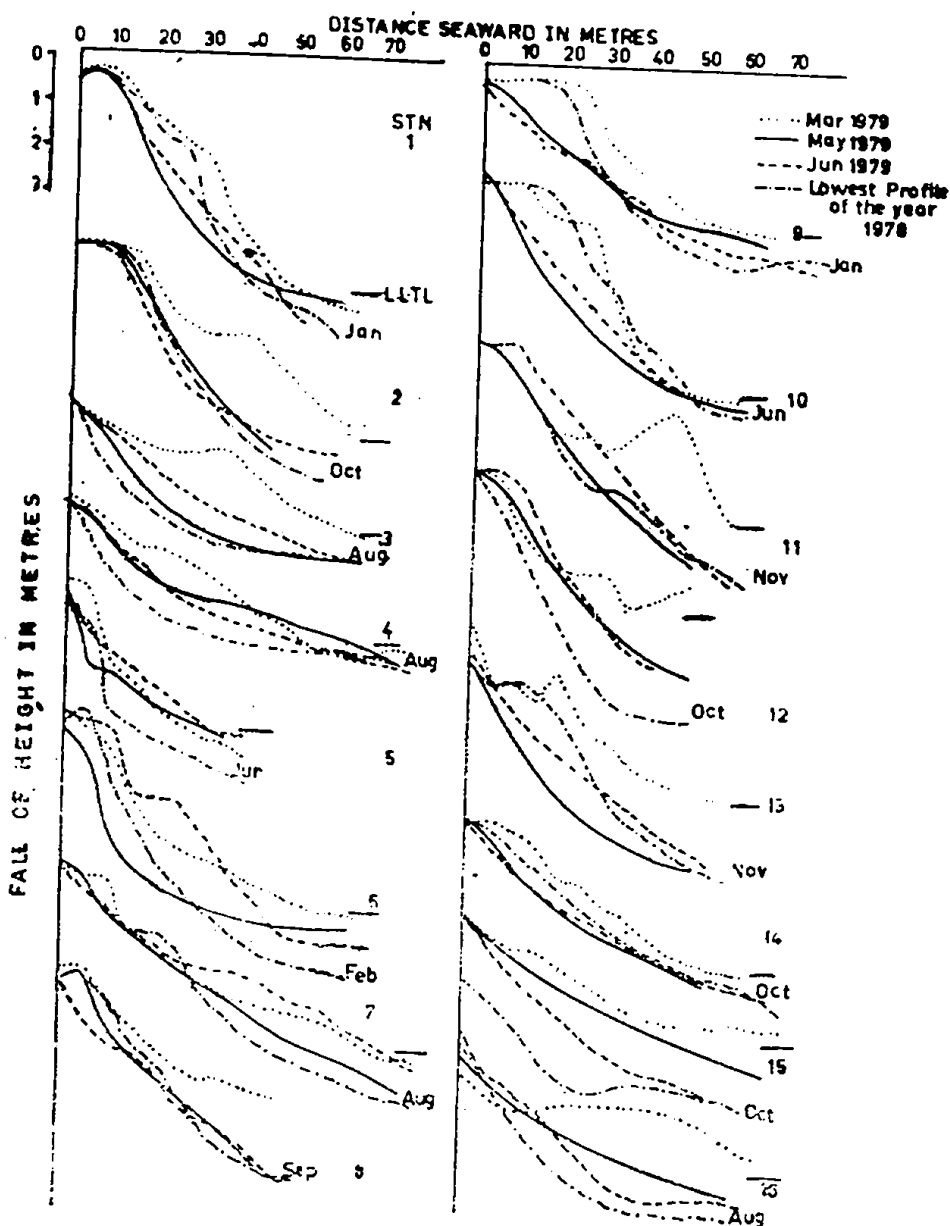
Fig. 3. Changes in the beach profiles.

The studies on the Visakhapatnam Beach indicate that the time of maximum erosion during an year occur at different places in different months as indicated by the observed lowest elevation of the beach profile (Fig. 3). This difference in the times of maximum erosion over 7.5 km long stretch was attributed to the presence of rock outcrops in the littoral zone (Reddy, 1962). In general, the Visakhapatnam beach undergoes erosion during southwest monsoon and accretion during north-east monsoon (LaFond and Prasada Rao, 1954). Considering the level of the maximum erosion of the year as datum, the quantity of material deposited along unit length of the beach in May 1978; March, May and June 1979 are calculated and given in Table I. The changes in beach levels during these months are plotted in Fig. 3. From Table I, it is inferred that at stations 8, 10, 11 and 13 the beach experienced severe erosion, quantitatively more than the annual maximum erosion. From Fig. 3, it can be observed that along this stretch of the beach berm height was lowered by 1 to 2 m. The dunes on the backshore experienced erosion due to the increased wave runup leading to vertical cuts of 1 to 3 m. Particularly erosion was very high between Red Light House and Palm Beach Hotel (stn. 8 and 9) and near Lion's Club Park (stn. 13). The condition of the eroded beach on 14th May near Red Light House and Lion's Club Park are shown in Figs. 4 and 5 respectively. Beach berm at these places completely scoured off and near Palm

Comparing the quantity of beach sediments in May 1978 and March 1979 (Fig. 3 and Table I), it is understood that the beach had experienced severe erosion due to the cyclone. The loss of material is quite substantial. From the observation taken in June 1979 it is inferred that parts of the beach near stations 2, 3, 5 to 7 and 10 to 13 experienced little deposition and the beach started to restore in one month. Consequently in the remaining part of the beach erosion continued and the beach lost additional quantity of the sediment. During the forthcoming southwest monsoon, this part of the beach is likely to experience additional erosion.
