**OBSERVATIONS OF POST TSUNAMI
RECONNAISSANCE INVESTIGATIONS ALONG
EASTERN COASTAL TRACT OF INDIA
FOLLOWING THE DEVASTATING TSUNAMI OF
26TH DECEMBER 2004**

NIO/TR-08/2005

NATIONAL INSTITUTE OF OCEANOGRAPHY
DONA PAULA, GOA – 403004, INDIA

JULY 2005

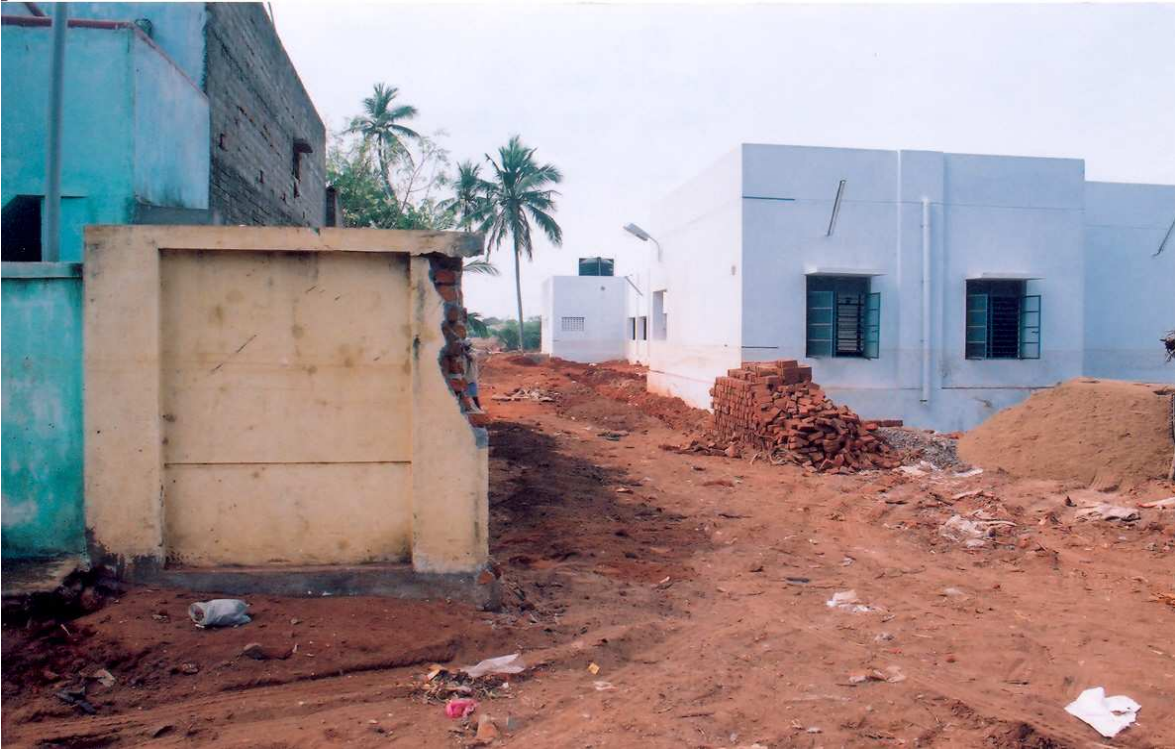
Plate 1. Tsunami water mark on the walls of a building in Periyakalpet. Such marks were used to deduce run-up and inundation limit.

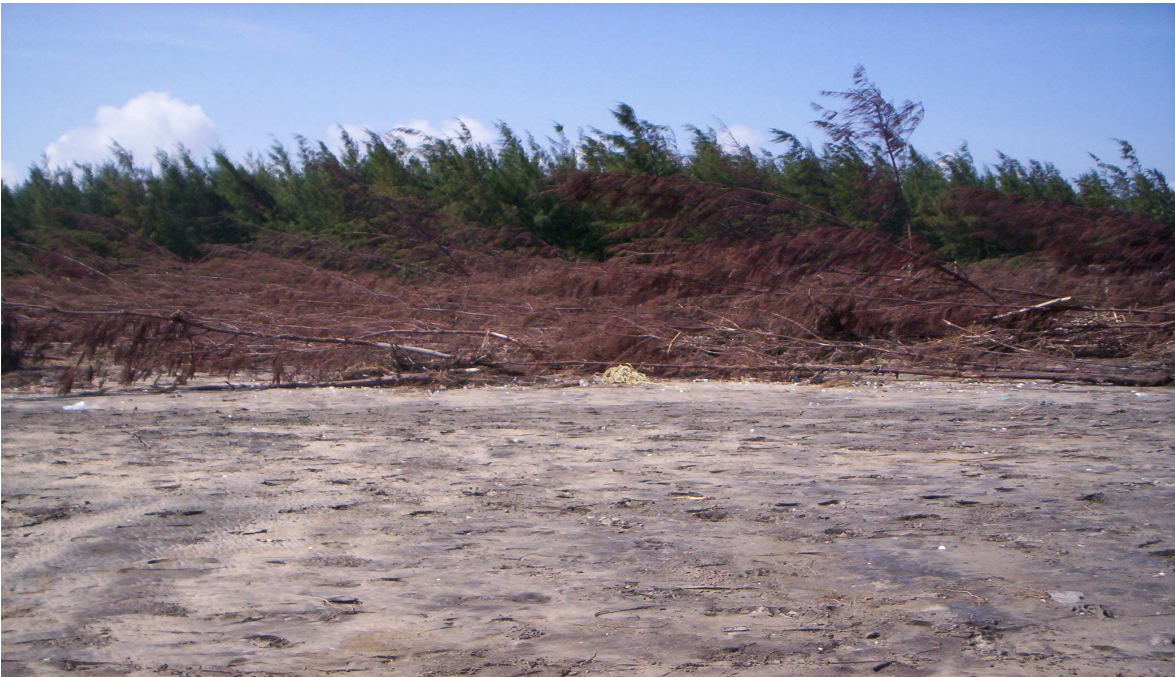
The directions of approach of tsunami at the beach were inferred from the directions of fallen trees (Plate 2), walls, poles, geometry of scour, etc.

Plate.2. Partial absorption of tsunami energy caused felling of seafont row of casuarinas trees. Such fallen trees were used to infer bearing of the tsunami. (Nagore)

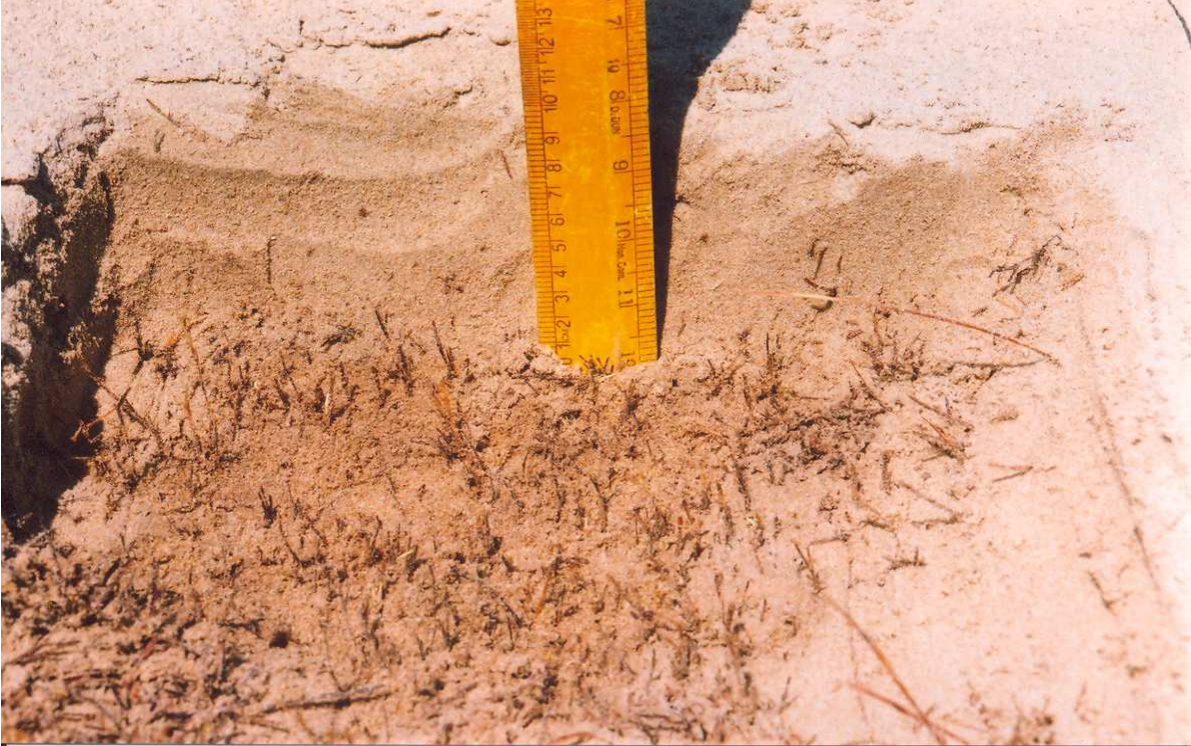
Plate 3. A dug out pit showing distinct tsunami transported sediments overlies dead pre-tsunami grass patch (Krishnapatnam)

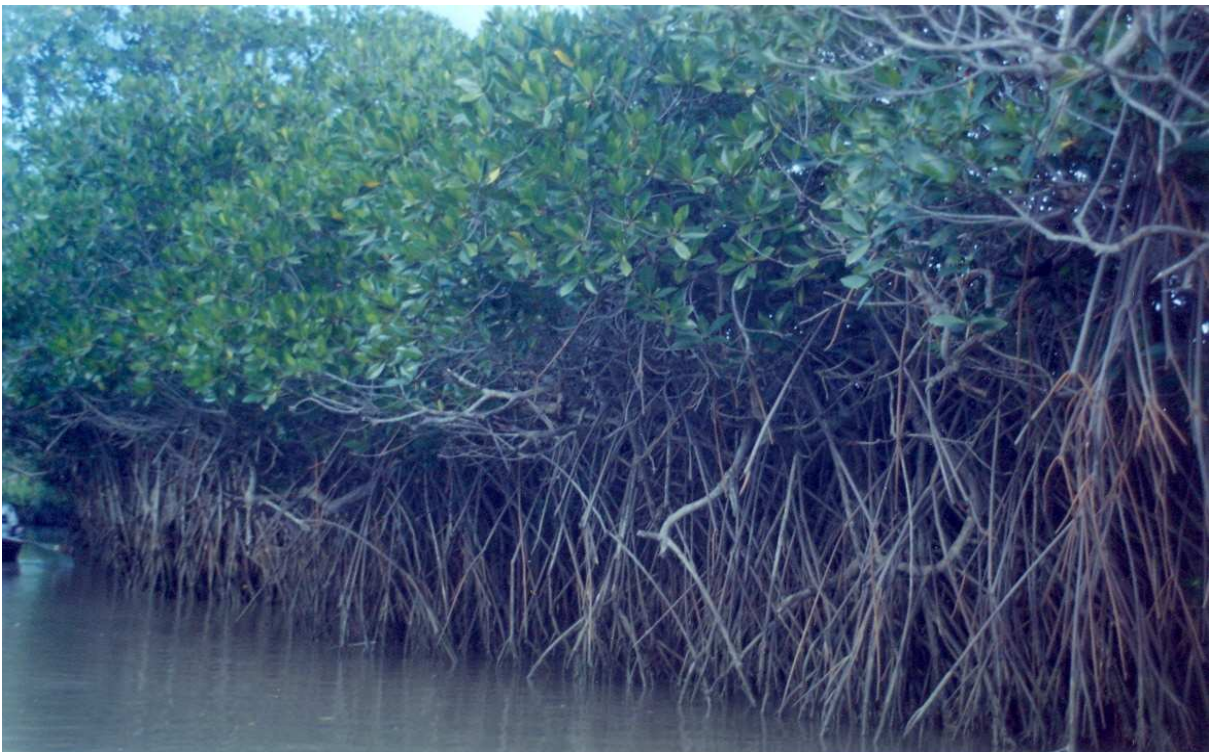
There are many natural and artificial coastal features such as sand dunes, dense coastal vegetations, break-waters, seawall, etc., which were found to have played considerable role in diffusing down high energy of tsunami waves. Due to dense mangroves in the Pichavaram, adjacent hinterland villages have escaped from inundation and damages. Plate 24 shows the intertwined stems of the mangroves plants at Pitchavaram which appear to have retarded the tsunami flow. Plate 2 shows absorption of tsunami wave energy by frontal rows of casuarinas trees. Plate 25 shows rubble mound seawall at Tarangambadi which has considerably reduced the tsunami wave impact over the structures seen behind it. In the same way structures along marine drive were protected due to dissipation of tsunami wave energy by the rubble-mound seawall.

Plate 24. Intertwined stems of mangrove plantation which appeared to have retarded the tsunami flow (Pitchavaram).

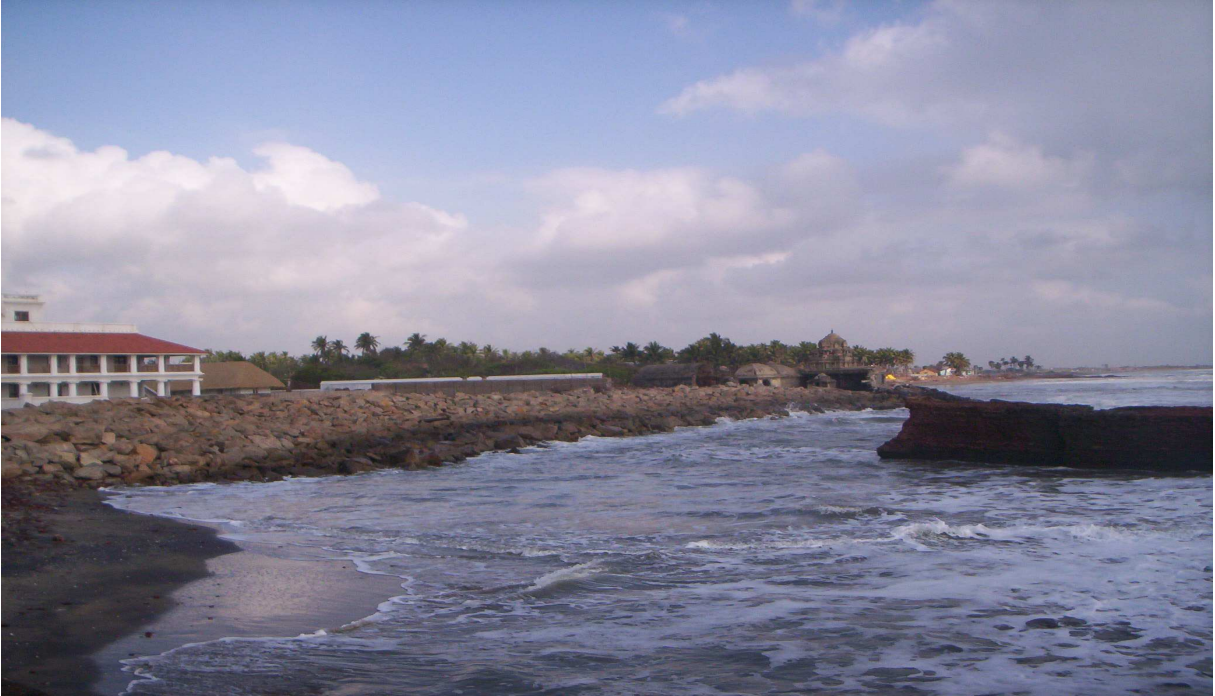
Plate 25. Rubble mound seawall which has considerably reduced the tsunami impact over the structures behind (Tarangambadi).
