BIOFOULING AND CORROSION ON WAVERIDER BUOY SYSTEMS

ABSTRACT

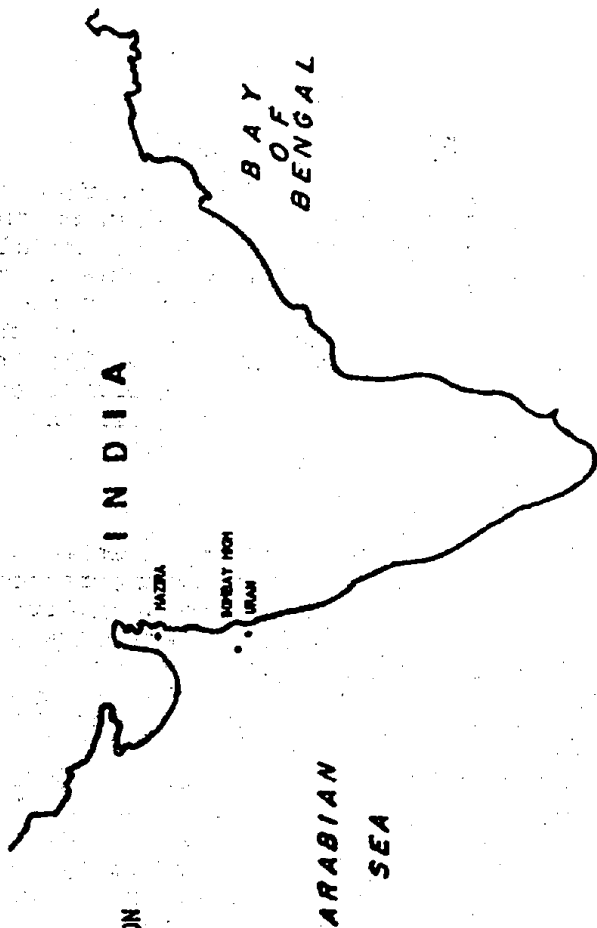
FIG. 1. WAYERIDER BUOY LOCATIONS.

S. NO.	LOCATION OF WAYERIDER BUOY.	WAYERIDER BUOY HULL MATERIAL.	PERIOD OF STUDY.	REMARKS.
1.	AT BOMBAY HIGH.	TYPE 316 S.S STEEL AND 90/10 COPPER NICKEL ALLOY.	22nd MAY to 12th DEC. 1984.	MODERATE CREVICE AND PITTING CORROSION ON TYPE 316 S. STEEL BUOY HULL AND HARDWARES.
2.	OFF URAN.	TYPE 316 S. STEEL.	26th JUNE to 16th OCT. 1984.	SEVERE CREVICE AND PITTING CORROSION ON BUOY HULL AND HARDWARES.
3.	OFF HAZIRA.	TYPE 316 S. STEEL.	22nd JUNE to 30th DEC. 1985.	REMEDIAL MEASURES ADOPTED PREVENTED FURTHER CORROSION ON BUOY HULL.

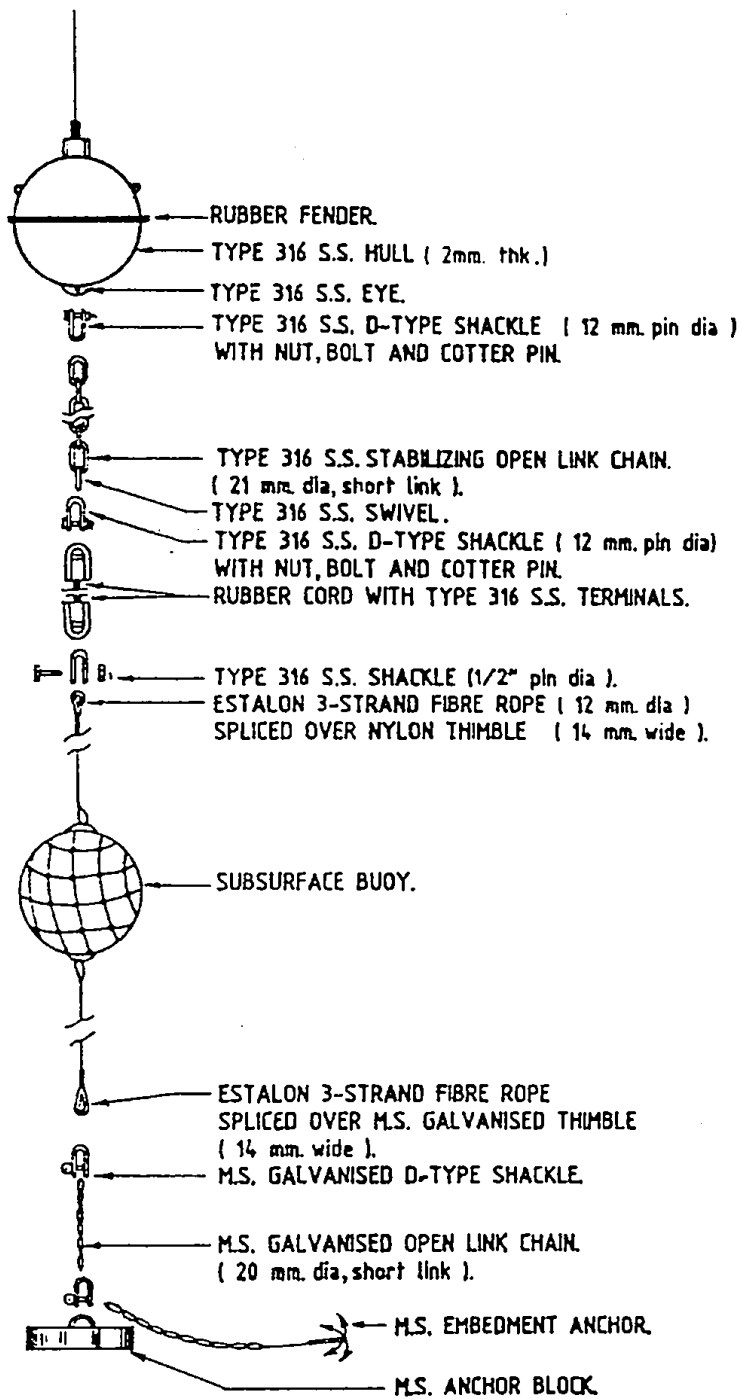
FIG. 2 A TYPICAL WAVERIDER BUOY MOORING SYSTEM. (Disassembled View).

Figure 2 shows a typical waverider buoy mooring system adopted by NIO. Various metallic connectors used in the mooring were made either of type 316 stainless steel or of galvanised steel. Measures were taken to

alleviate the galvanic corrosion between the dissimilar metals connected together in the mooring system. All directly inter connected metallic hardwares in the mooring system were of identical metals.

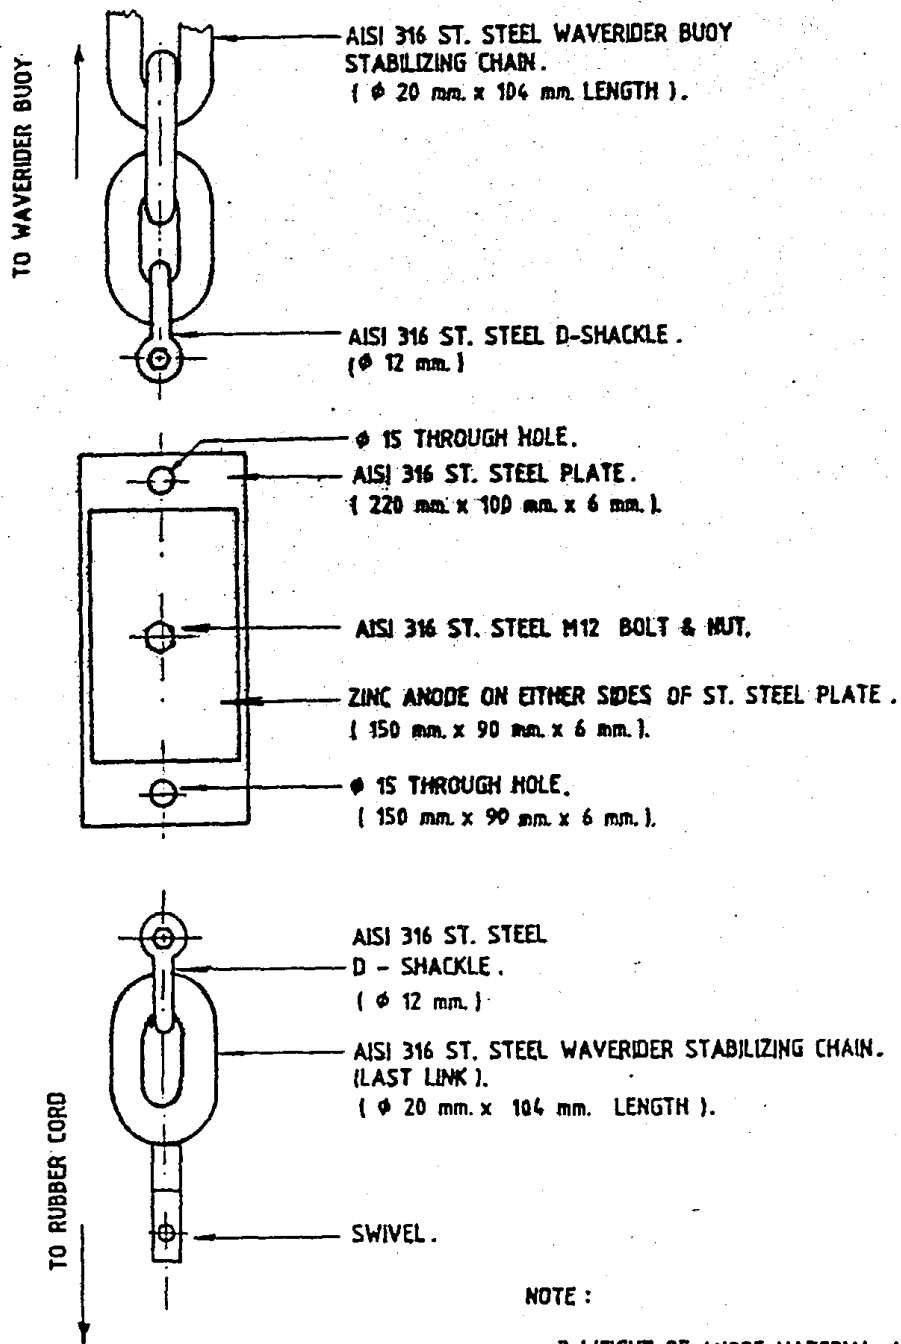
The D-type shackles made of 316 stainless steel used for connecting the rubber cord to the waverider buoy was also found to be severely pitted (Figs. 6 & 7) in the crevice formed between the locking bolt head and its mating U-body area of the shackle, in the crevices formed between the locking nut and its mating U-body area of the shackle as well as in the crevices formed between the threaded contact surfaces between the locking nut and bolt. The depths of the pits formed varied between 3 to 5 mm.

FIG. 11. X SACRIFICIAL ZINC ANODE
PROVIDED ON 316 S.S. SHACKLE.

It is recommended to use type 316 stainless steel hardwares in the mooring. If galvanised steel components are used in the mooring necessary allowance to cover the corrosion losses has to be provided. Fig. 11 shows cathodic protection used at N.I.O. on type 316 stainless steel D-shackles by clamping a zinc sacrificial anode.
