NIO'S EXPERIENCES IN DATAWELL WAVERIDER BUOYS

S. G. DIWAN, A. K. SURYAVANSHI & B. U. NAYAK
National Institute of Oceanography
Dona Paula, Goa-403 004

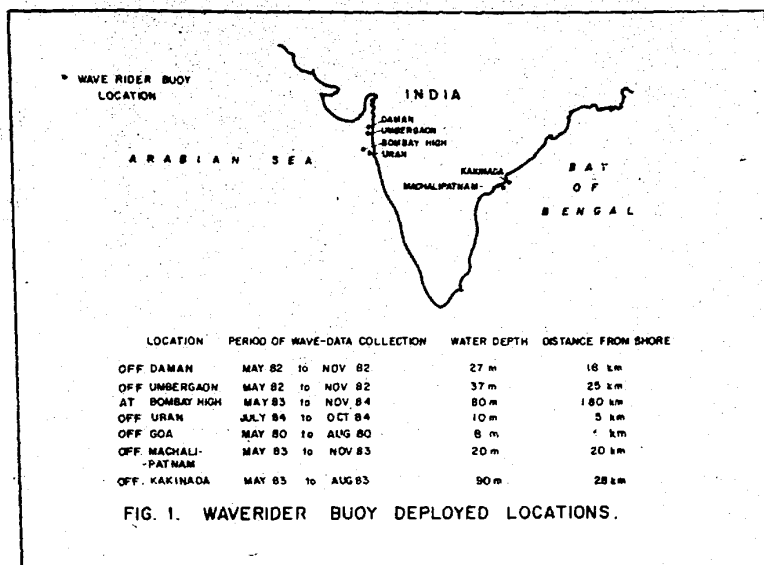
A few mooring failures occurred as the rubber cord got cut and the buoy drifted freely in the sea. These failures were attributed to the entangling of the drifting fishing nets with the waverider mooring and interference of passing boats/vessels. Prolonged excessive tension in the rubber cord seems to cause this failure. In other cases the rubber cords were found cut presumably by the fishermen while separating the fishing nets entangled with the waverider buoy mooring, thus causing the waverider buoy to drift freely in sea. Fig. 3 shows the photograph of a damaged rubber cord. The buoy deployed off Umbergaon drifted to a rocky shore at about 250 km north from the anchored position. Later this buoy was traced and recovered from a local fishermen in Baroch district of Gujarat. The Cunnifer U-eye on the waverider bottom provided for connecting the stainless steel stabilising chain was found broken (Fig. 4). This seemed to have occurred due to mis-handling of the buoy by the fishermen. The upper aerial spring was also found bent.

FIG. 3 ⊗ - BROKEN RUBBER CORD END
