Natural hazards, disasters and human kind: whither ecosystem management?

ANTONIO MASCARENHAS and ABHAY V. MUDHOLKAR

National Institute of Oceanography, Dona Paula 403004, Goa, India

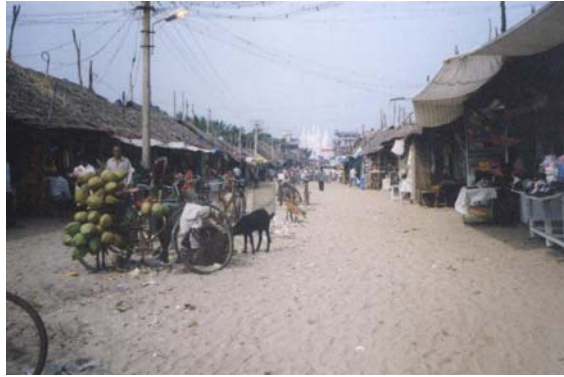
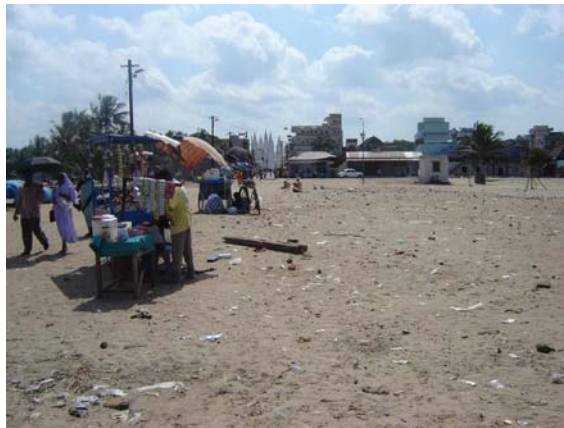
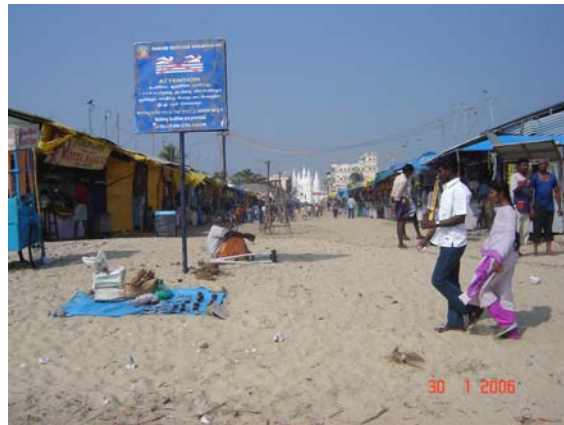
Figure 1: Business as usual: the scenario along Velankanni beach before (1998) and after the December 2004 tsunami. Top: Makeshift structures occupy entire beach width of 75 meters (November 1998); Centre: Made of bamboo and coconut leaves, the thatched huts were washed off in totality and the beach was flattened (April 2005); Bottom: One year later, the shops are back despite monetary losses (January 2006). Note full fledged electricity connections along with a sign board warning about tsunamis. The shrine of Velankanni is seen in the background (Photos: A. Mascarenhas, NIO, Goa).

Following the December 2004 tsunami, human settlements were destroyed, huts on dunes were washed off, improvised wooden shops vanished, and some coastal villages were wiped off entirely. The reason for such a disaster was that crowded houses were built too close to the shore, on levelled sand dunes. With an absence of buffer zones, and flouting of coastal regulations, habitations were impacted by direct wave attack (Mascarenhas, 2006; Mascarenhas and Jayakumar, 2008). One year later (January 2006), despite adverse impacts, hectic rebuilding activity was observed at several places, make-shift huts are back (Figure 1); most houses are rebuilt on former foundations, with coastal setbacks treated with impunity (Mascarenhas and Jayakumar, 2008). Similarly, sea walls were overrun, dissected and dislodged by mighty waves, a bridge column 1 km upstream was dislocated (December 2004). That was because there is no way to protect a sea wall from direct hit by virulent oceanic forces. One year later (January 2006), the boulder wall at Pondicherry city is widened (Figure 2), and the one at Nagapattinam port was rebuilt in concrete (Figure 3), at a higher cost, and as a taller and longer fortification (Mascarenhas and Jayakumar, 2008). Thus, after the initial panic subsided, it was business as usual at several coastal sites in Tamil Nadu.

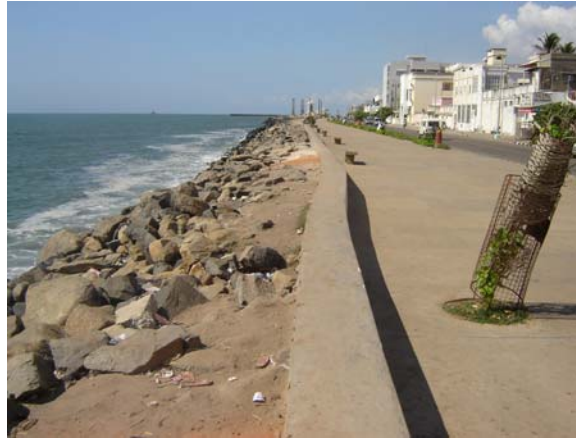
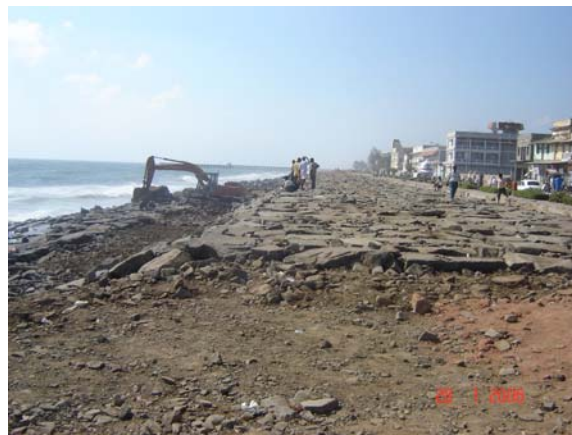
Figure 2: An example of bureaucratization of sea walls. Top: A modest rubble protection wall existed at Pondicherry since long (April 2005); the tsunami did not affect the city coast, except for mild overwash; Bottom: The sea wall, now with large boulders, has been extended about 30 meters sea ward for no reason whatsoever (January 2006) (Photos: A. Mascarenhas and S. Jayakumar, NIO, Goa).

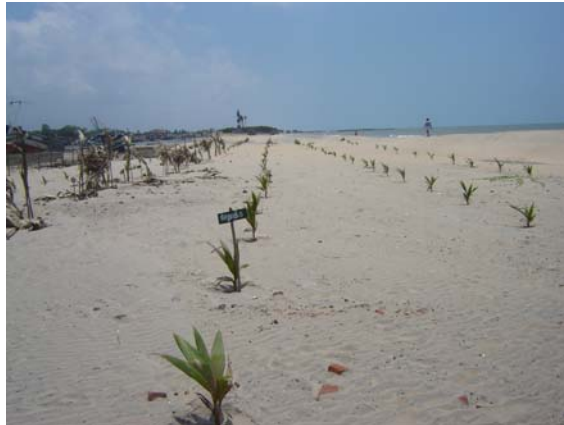
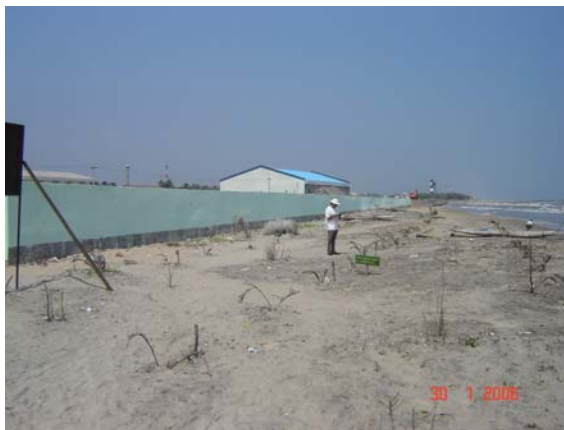
Figure 3: In what appears as a challenge against eventual natural extreme events, the earlier low sea wall (April 2005) that was overtopped by the tsunami, has been extended about 150 meters southward as a taller and broader concrete fortification; beach erosion has already started at the distal end (January 2006). Also note that fear impelled villagers to plant coconut saplings on the beach; these plants perished within a year. The Nagapattinam light house is seen in the background (Photos: A. Mascarenhas and S. Jayakumar, NIO, Goa).
