ENVIRONMENTAL STUDIES OF THE EZHUMALA BEACH

ABSTRACT

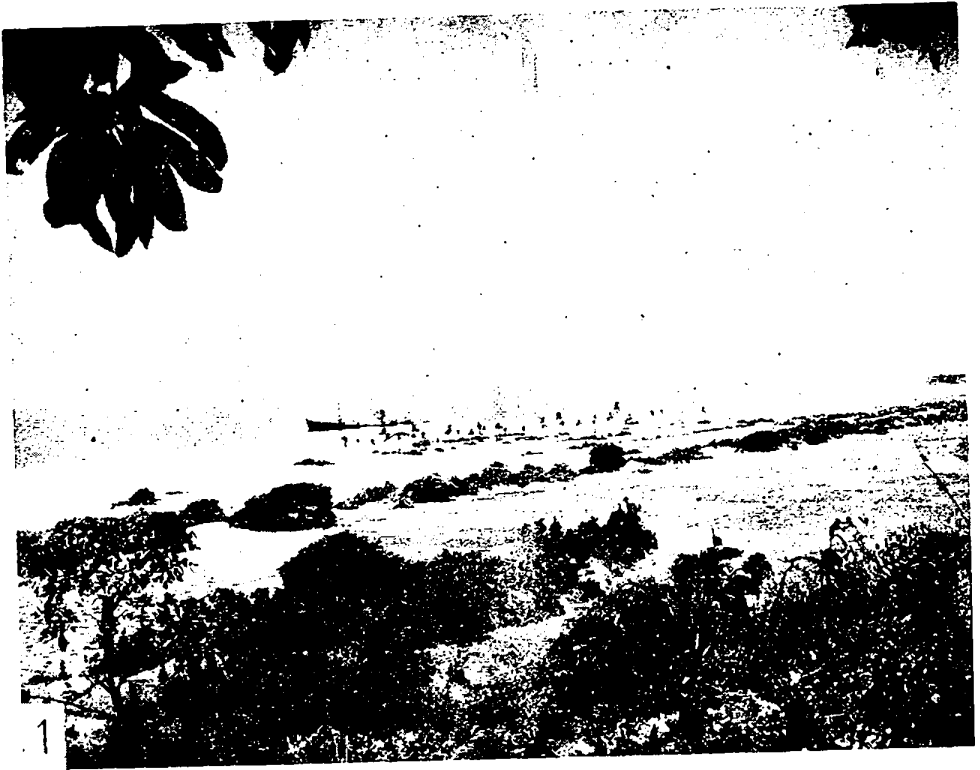
Fig. 1. "Good Fortune" Panama ship stranded at Ezhumala.

In August 1978 a Panamanian cargo vessel "Good Fortune" ran aground at Ezhumala and during the first visit in September 1978 the area was examined critically for possible ill-effects of which there were none. The dampening of waves in the zone between the ship and the shoreline resulted in accretion of sediments in this area and tongue like extension of the shoreline was seen developing there. The ship in effect acts like a break water (Fig. 1).
